TECHNICAL MEMORANDUM B.1.5

Regional Municipality of Wood Buffalo

Wastewater Collection System Master Plan

Hydraulic Model and Design Criteria Update

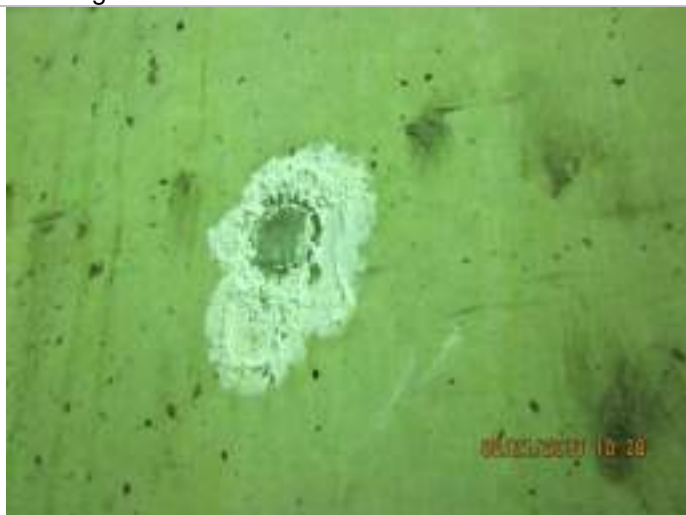
Photo 2: Water staining on Dry Well south wall.

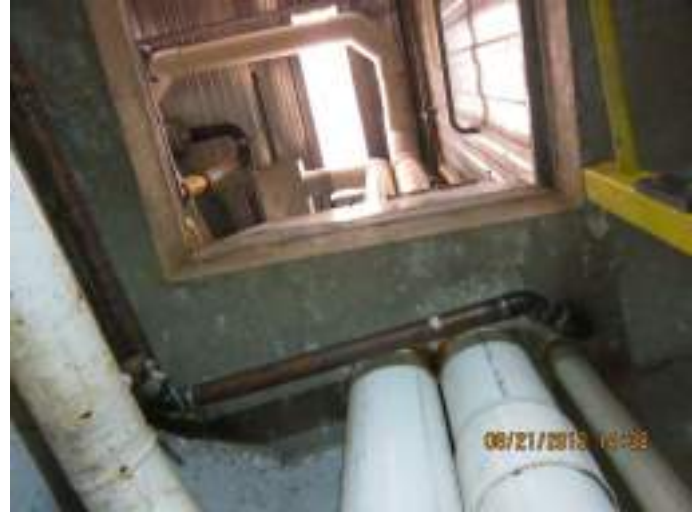
Photo 5: Crack in main floor concrete floor slab on Dry Well side to be sealed.

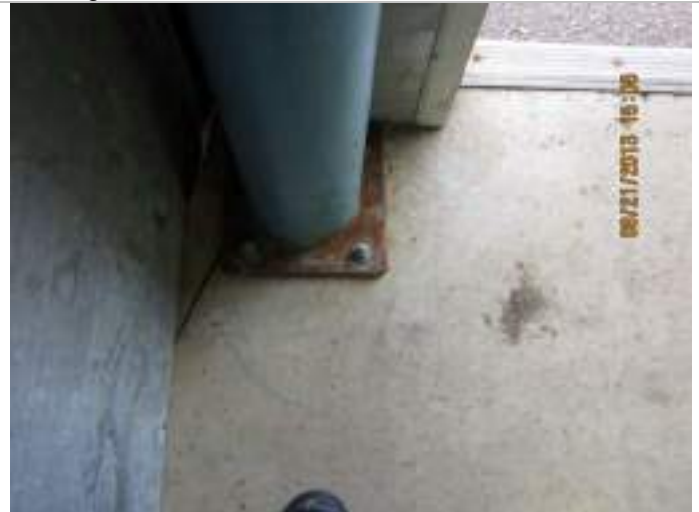
Photo 7: Monorail beam is corroded where it extends outside through door. Clean with wire brush and re-paint.

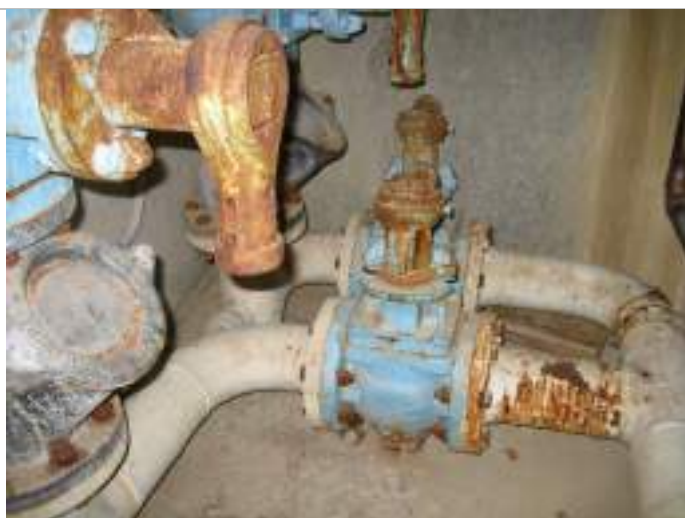
Photo 3: Rusting of fittings, valves, bolts, etc.

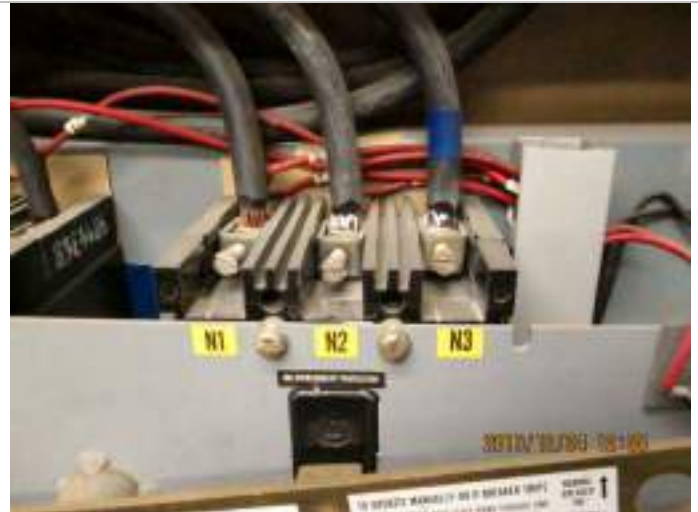
Transfer panel is old and is most probably unreliable and difficult to maintain.

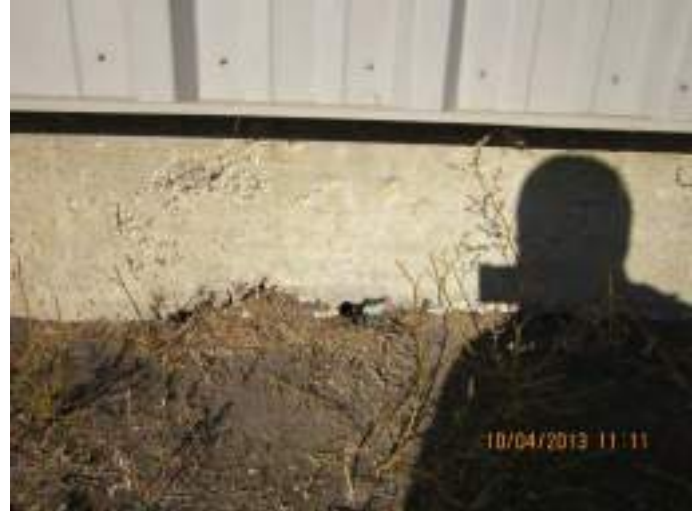
Photo 1: East side of building with voids and segregation of concrete foundation.

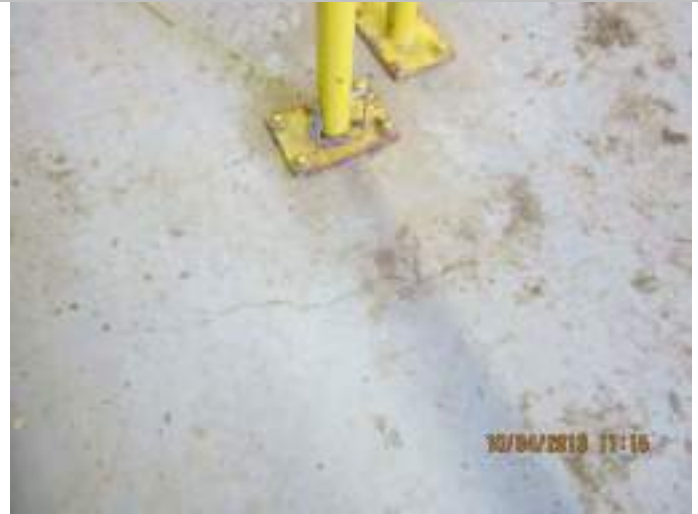
Photo 5: Paint is peeling off of main floor concrete slab.

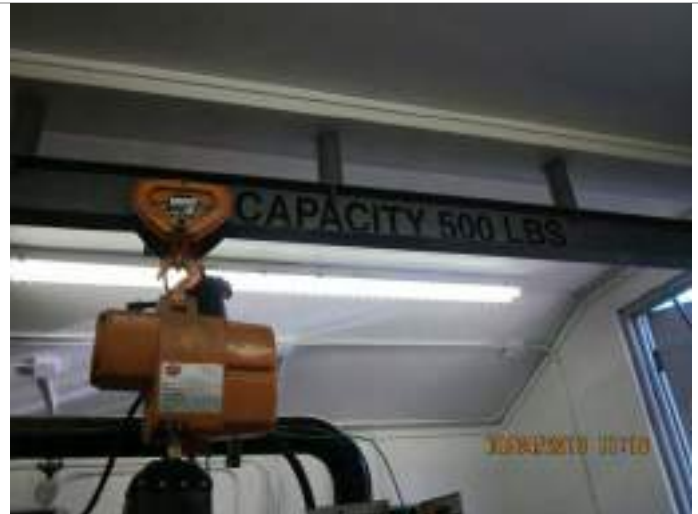
Photo 7: Crack in main floor concrete floor slab.

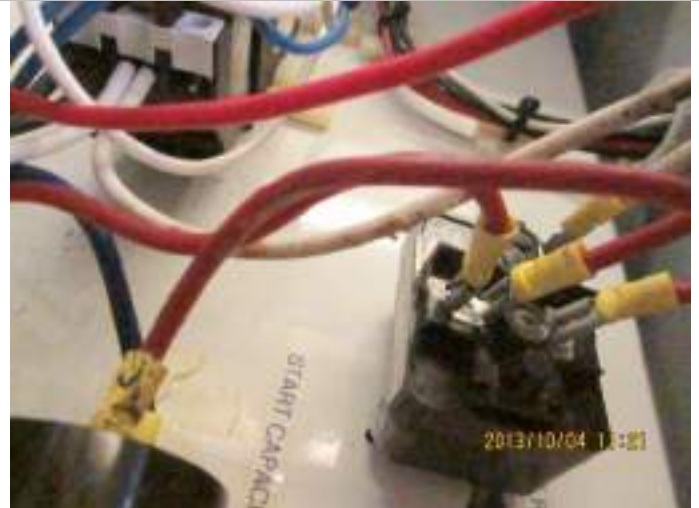
The pump panel requires rebuilding and maintenance to ensure reliability.

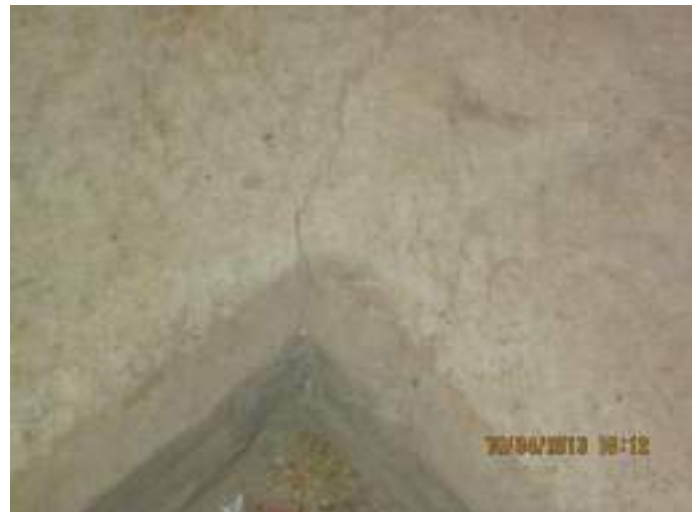
Photo 7: Shrinkage cracks in the Dry Well main floor slab near the stair opening.

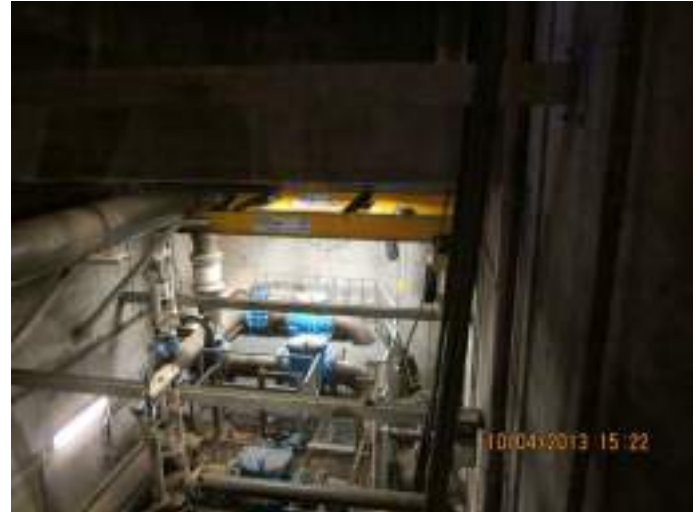
Photo 9: Shrinkage cracks in the Wet Well wall where a pipe passes through the wall.

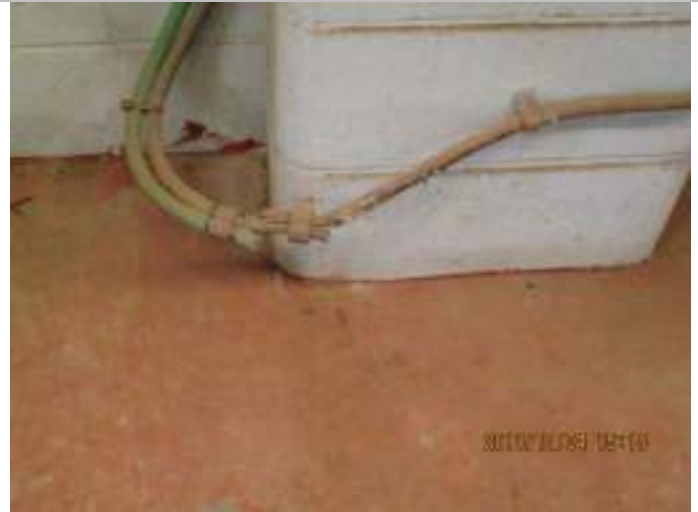
All 480VAC equipment seems to be approaching end of life.

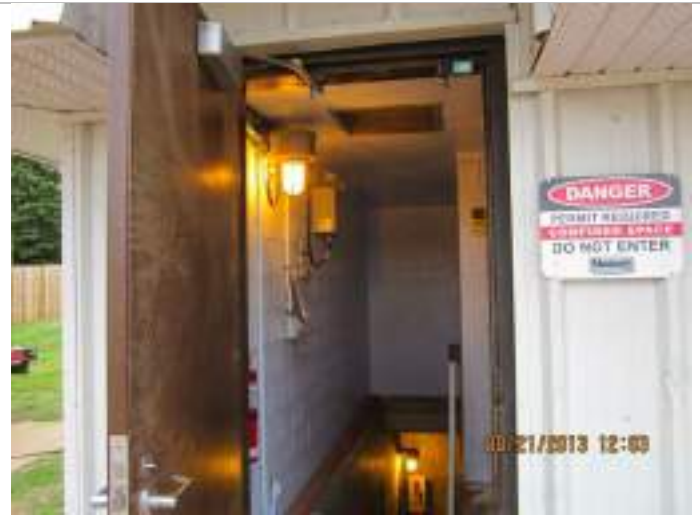
Photo 1: Front entrances of Cornwall Sewage Lift Station. The apron slab has spalls and cracks that need repair.

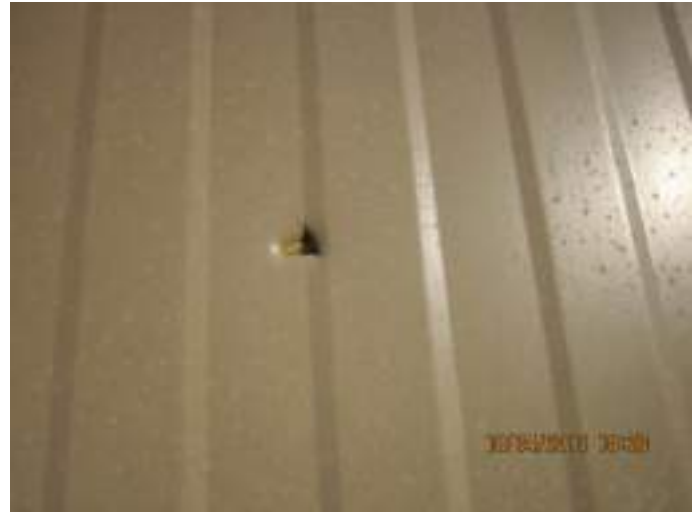
Photo 1: South Exterior Wall with damage to cladding.

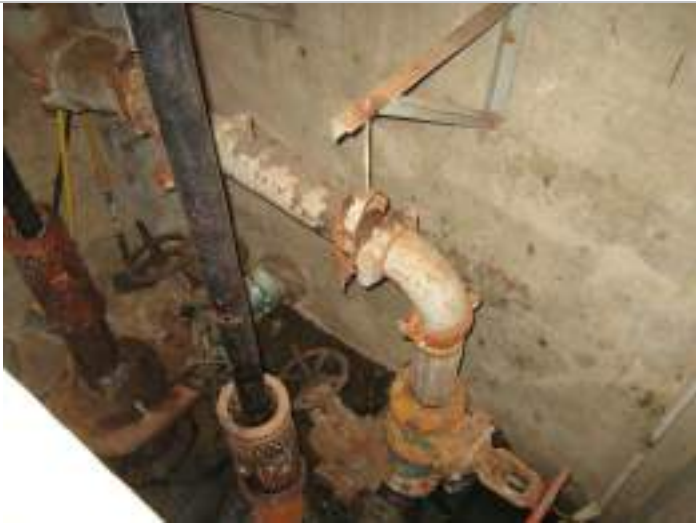
Photo 2: Pump #1 – Leaking seals.

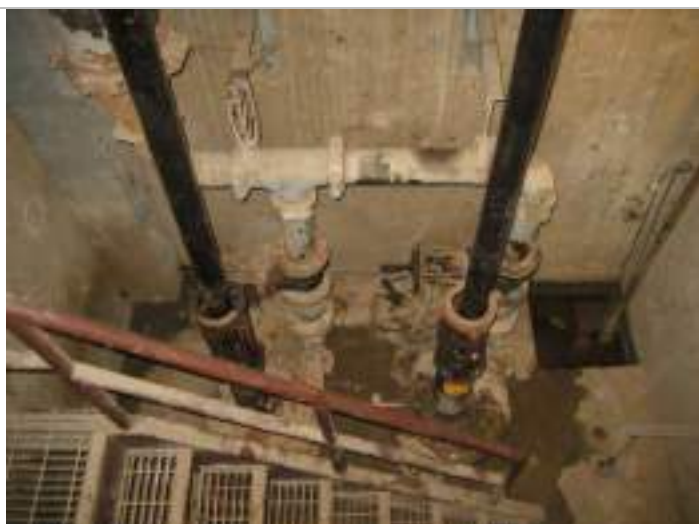
Photo 2: Pump #1 – Leaking seals.
