April 24, 2022 1400h – **River Breakup Declared**

Alberta Rivers and Parks River Forecast Centre Update

Ice Jam Watch lifted for Fort McMurray

Regional Emergency Coordination Centre (RECC) Update

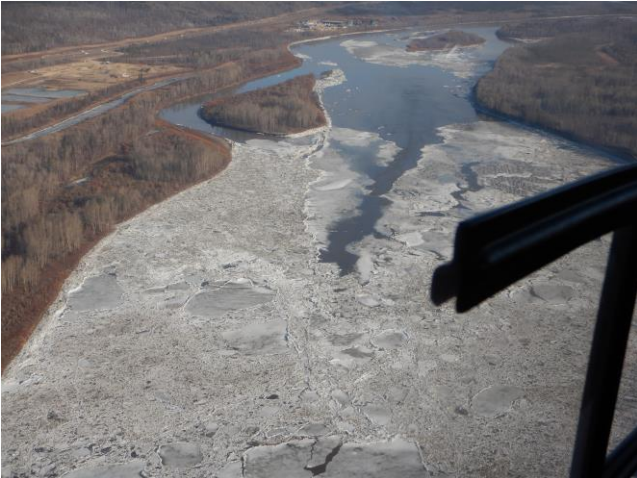
Ice jam toe of the 4.5 km ice jam on the Athabasca River near Fort McMurray (flow from right to left) at km 281. Photo taken April 24, 2022, courtesy AEP.

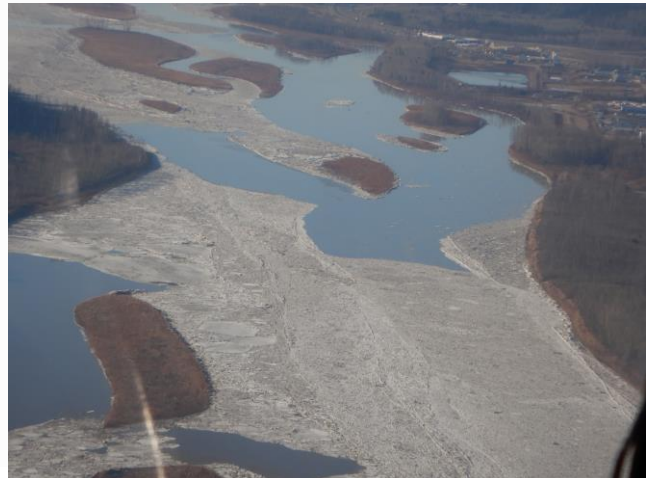
Ice jam head of the 4.5 km ice jam on the Athabasca River near Fort McMurray (flow from left to right) at km 285.5. Photo taken April 24, 2022, courtesy AEP.

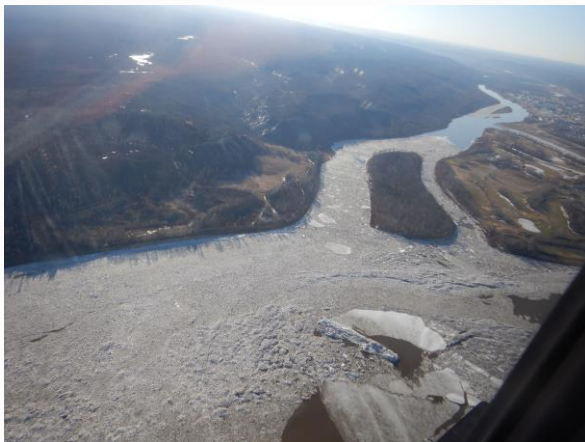
Heavily melted ice run on the Athabasca River (flow from left to right) at km 402. Photo taken April 24, 2022, courtesy AEP.
