### Alberta Rivers and Parks River Forecast Centre Update

**Ice Jam Watch remains in place – Issued April 20, 2022**  
**Ice Run now downstream of Fort McMurray**

# River BREAKUP

## Regional Emergency Coordination Centre (RECC) Update

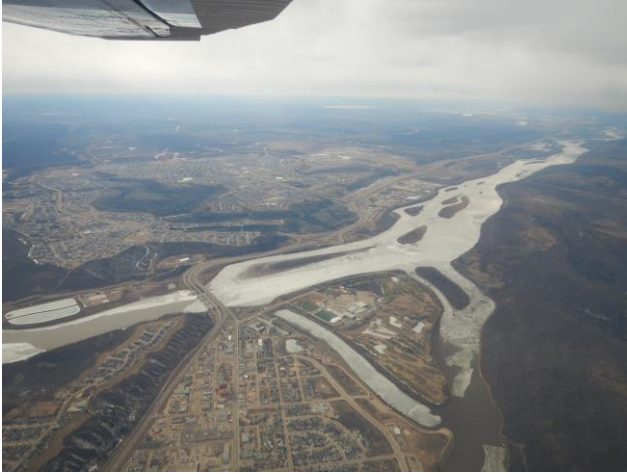
Intact ice cover on the Athabasca River (flow from right to left) at Fort McKay (at km 239). Photo taken April 21, 2022 courtesy AEP

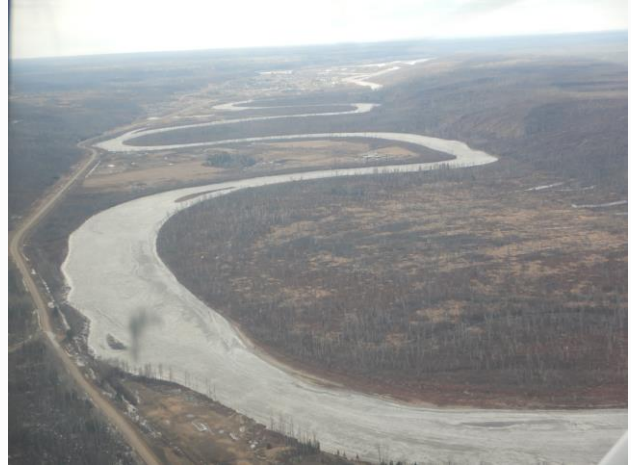
Intermittent ice cover on the Clearwater River (flow from bottom to top) at km 3. Photo taken April 21, 2022 courtesy AEP

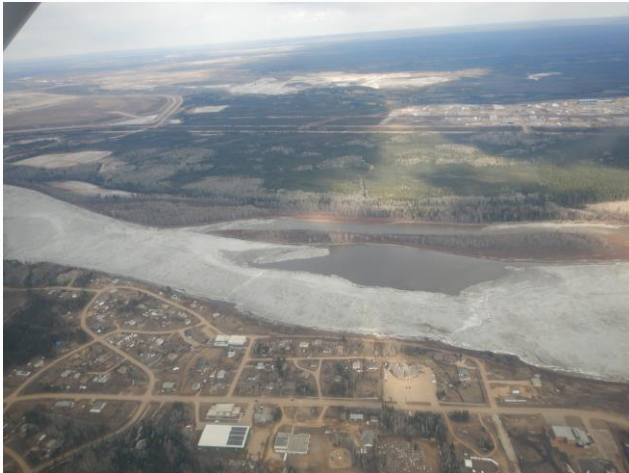
Intact ice cover on the Clearwater River (flow from bottom to top) at km 15. Photo taken April 21, 2022 courtesy AEP

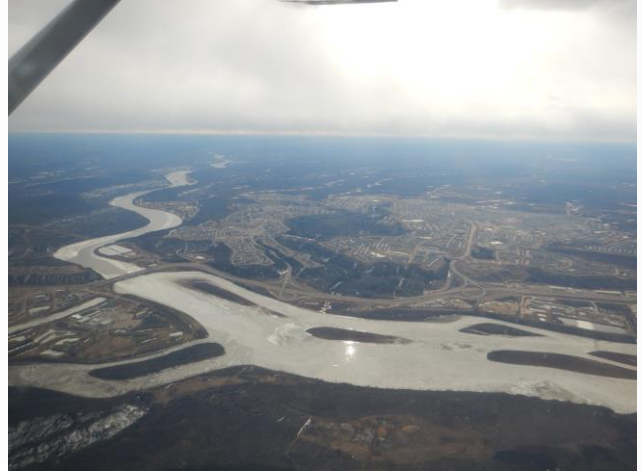
- The ice runs were completely stopped and formed an ice jam by 13:30 MDT today
  - The toe (leading edge) of the ice jam was located at km 283 (near the aggregate pit, 12 km downstream of Fort McMurray) and the head (tailing edge) was located at the Highway 63 bridges at Fort McMurray.

- The jam was 12 km long this afternoon, and was melting from the upstream end
  - Athabasca River ice was pushed ~1.5 kms up the Clearwater from the mouth

Ice jam at the confluence of the Athabasca River (flow from right to left) and the Clearwater River (flow from top-right to bottom) at Fort McMurray (at km 293). Photo taken April 21, 2022 courtesy AEP
