Alberta Rivers and Parks River Forecast Centre Update

Ice Jam Watch remains in place – Issued April 20, 2022
Ice Run now downstream of Fort McMurray

Regional Emergency Coordination Centre (RECC) Update

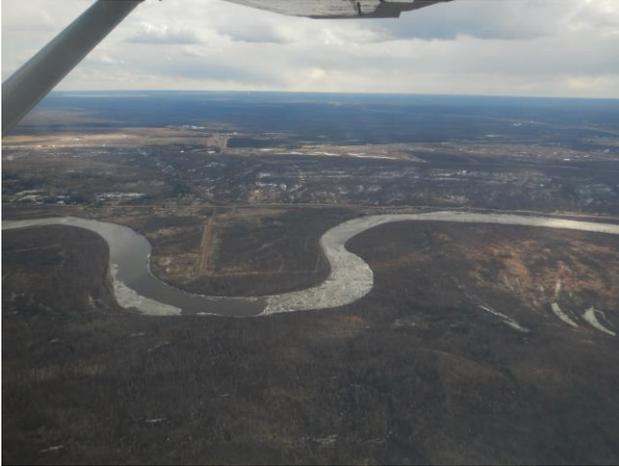
Small ice jam on the Clearwater River (flow from left to right) at km 16. Photo taken April 22, 2022 courtesy AEP

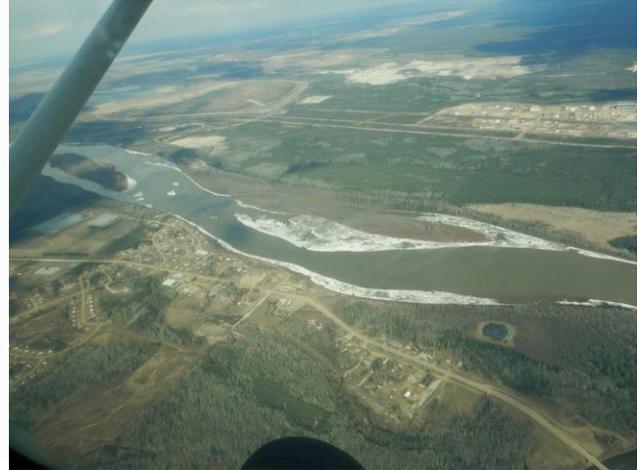
Open water on the Athabasca River (flow from right to left) at Fort McKay (approximately km 239). Photo taken on April 22, 2022. Photo courtesy AEP

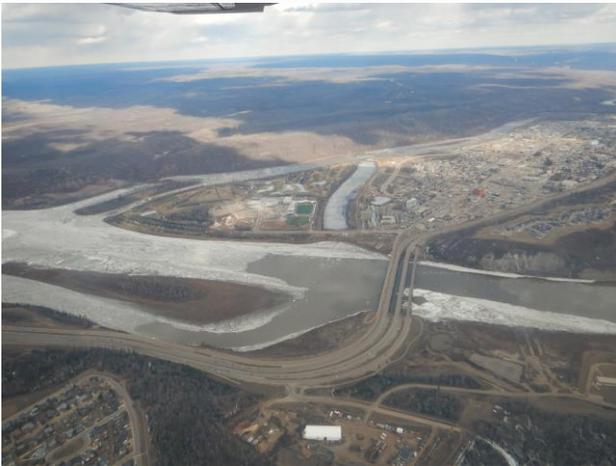
Head of ice jam on the Athabasca River through Fort McMurray (flow from right to left) at km 294.1. Photo taken on April 22, 2022 courtesy AEP.

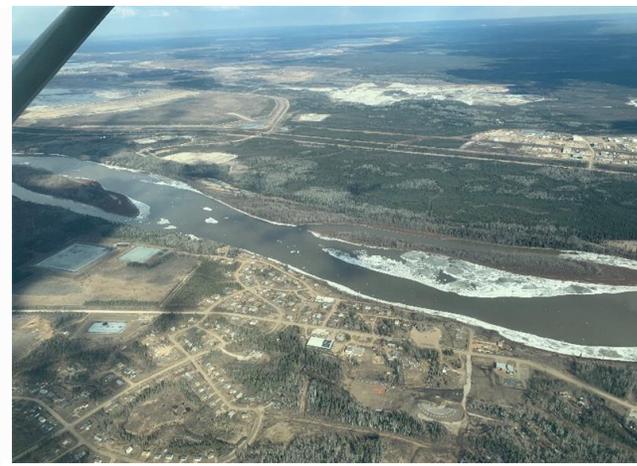
Open water at Fort McKay. Photo taken on April 22, 2022 courtesy AEP.
