TECHNICAL MEMORANDUM B.1.5

Regional Municipality of Wood Buffalo

Wastewater Collection System Master Plan

Hydraulic Model and Design Criteria Update

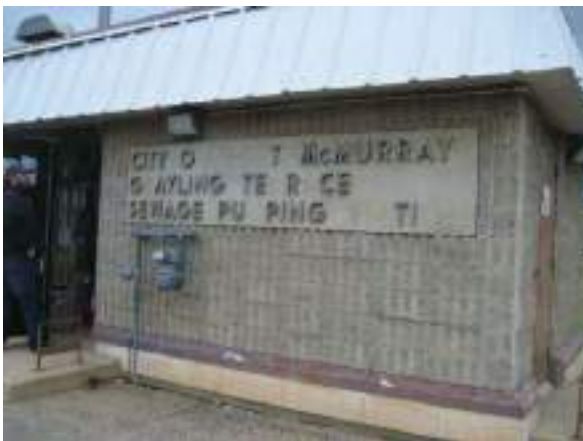
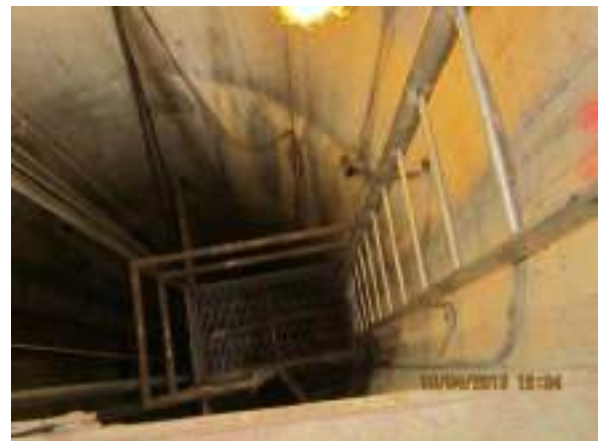
Figure 6-1
Grayling Terrace Lift Station

- Structurally, most lift stations are in satisfactory condition. Some cracking is evident at Grayling Terrace, and 1A. There is some surface rust or corrosion evident at four of the facilities (Eco-Park, Prairie Creek, Grayling Terrace, and Wood Buffalo).

- Minor rust/corrosion repairs should be completed where obvious on both the concrete and exposed steel in the facilities to prevent further deterioration.

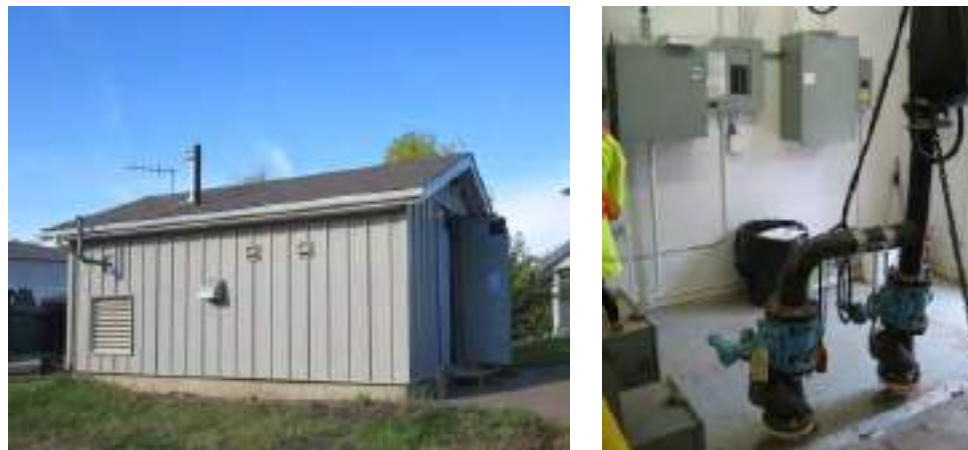
Figure 7-1
Abasand (Riverview Heights) Lift Station

- There is a major electrical concern at the Abasand lift station. The wet well access is inside the building housing all the electrical/instrumentation equipment and wiring. If the gases from the wet well escape into the building, an electrical spark could ignite the gases and cause a fire or explosion. Many (5) of the other lift stations do not have intrinsically safe barriers for the level (Flygt) bulbs in the wet wells. These could also cause an explosion if gases built up in the wet well, and the level indicator cabling was damaged. There are also minor upgrades at some of the stations that should be implemented, including grounding concerns and non-functional instruments.

- Isolate the wet well access from the electrical equipment room at the Abasco lift station. The current installation is a potential explosion hazard, and violates the Canadian Electrical Code.

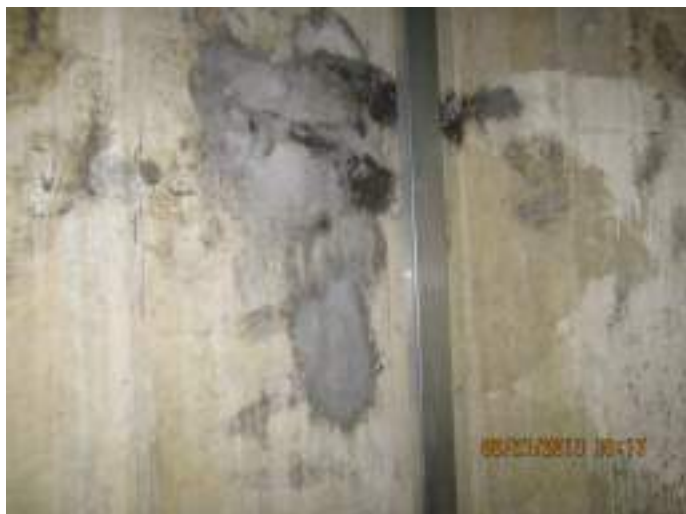
Photo 1: Dry Well concrete wall patch has minor cracking.

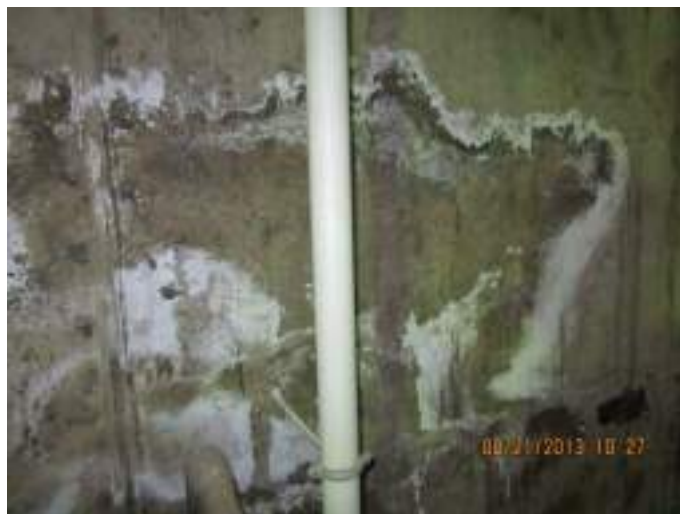
Photo 2: Water staining on Dry Well south wall.

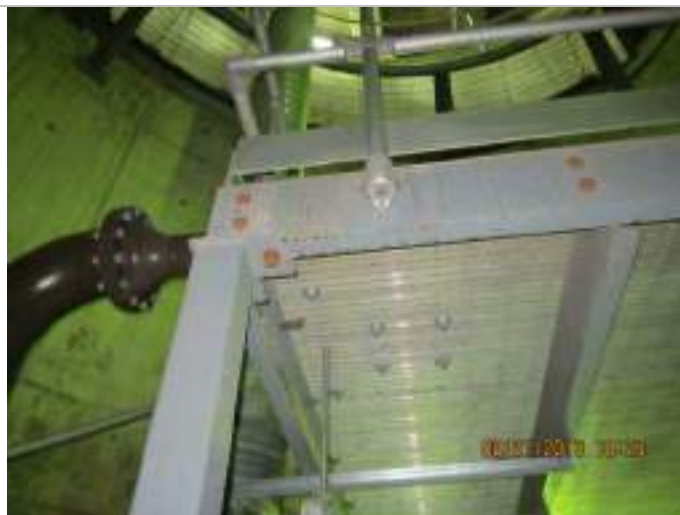
Photo 4: Minor corrosion on platform channel and bolts.

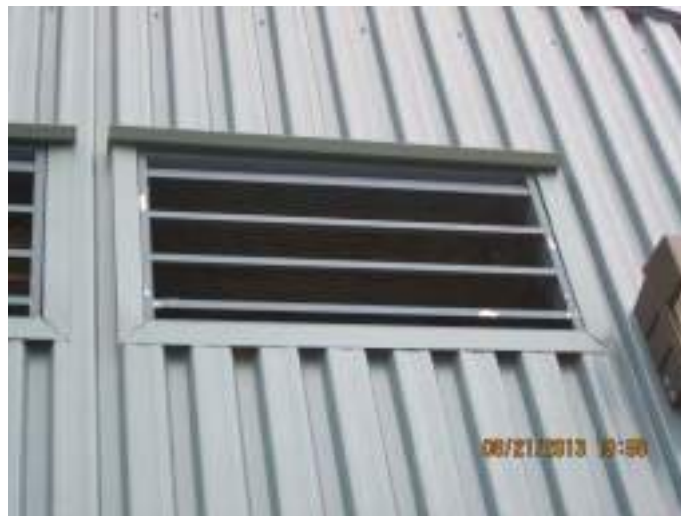
Photo 6: Loose chipped paint on the exterior wall louvers

4. Monitor cracks in the main floor slab at the double doors. Seal them if they become worse.
5. Remove loose chipped paint on the exterior wall louvers and re-paint to prevent corrosion. Replace the missing section of metal siding on the bottom of the wall on the south side. Sand off minor corrosion and re-paint the bottom flashing on the siding at the door.

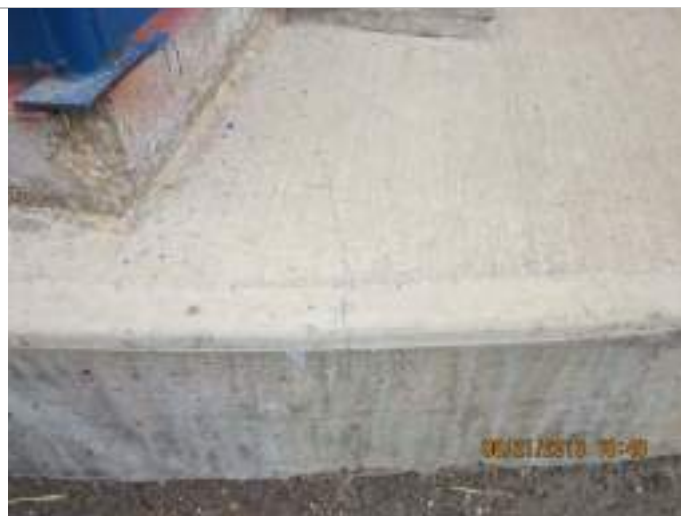
Photo 8: Cracks in the roof slab over the Wet Well.

6. Seal cracks in the roof slab over the Wet Well to prevent further cracking and spalling.
7. Chip out the tie hole patch in the antennae foundation to find the source of the rust staining. Clean up and epoxy paint the rusting steel and re-patch the concrete with an approved grout.

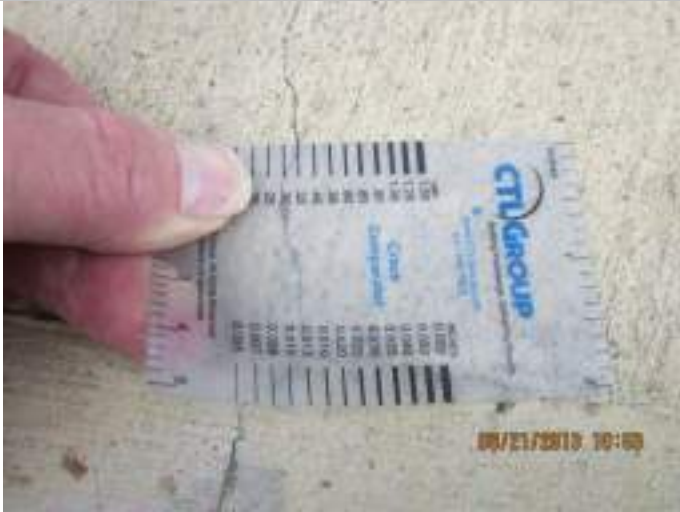
Photo 9: Cracks in the roof slab over the Wet Well greater than 0.3 mm.

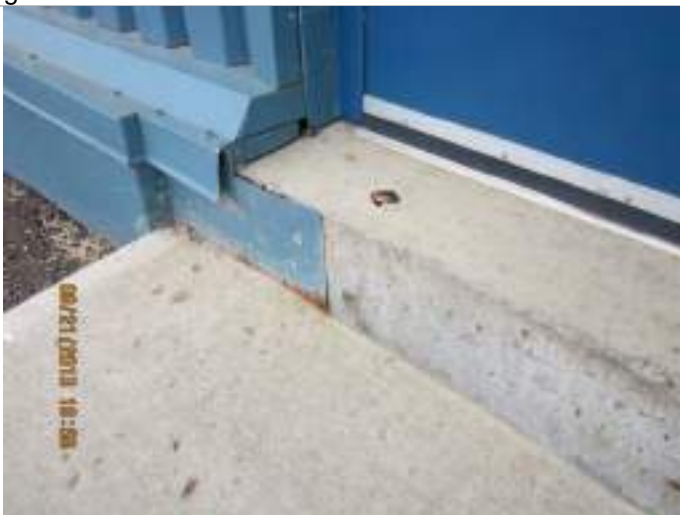
Photo 11: Cracks in the main floor slab at the double doors.

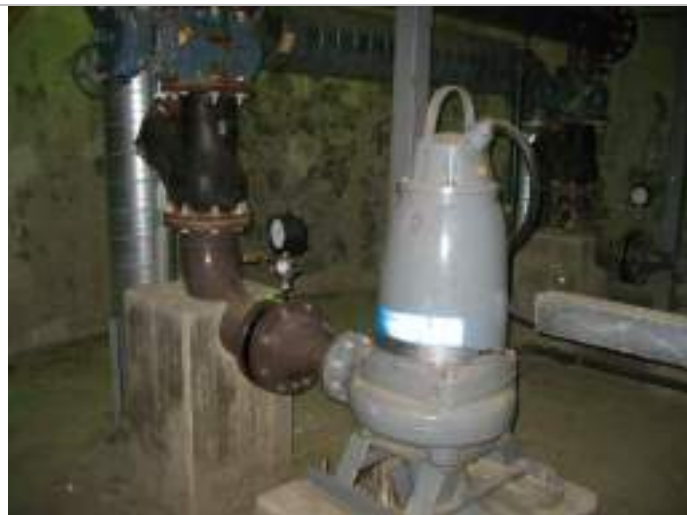
Photo 1: SWP – 401 & discharge valves, piping

- Confirm pressure reading differentials when SWP-401 is operating.
- Check actual vs. design flows.

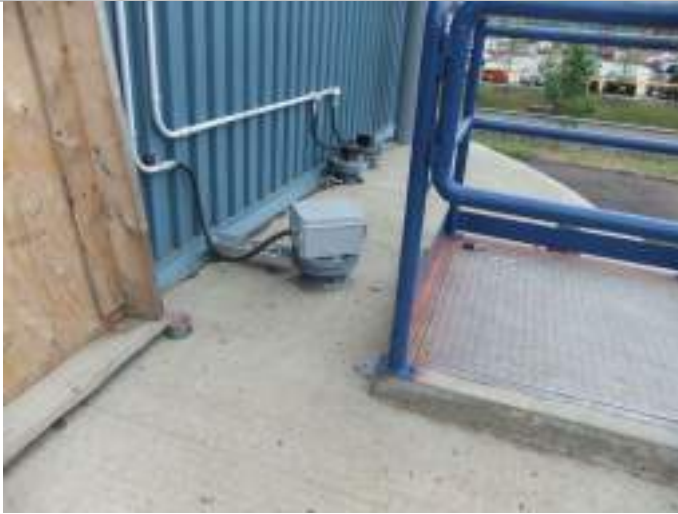
Photo 1: Bolts for the LIT are in the cable tray

1. The Flygt bulbs could have an intrinsically safe relay installed, Flygt makes one with a built in relay.
2. The power meter was not displaying current, maybe there were no current transformers, or it could have failed..
3. The HVAC unit should be investigated before winter. The ventilation did not turn on as intended.
4. Bolt down the LIT (complete the installation).

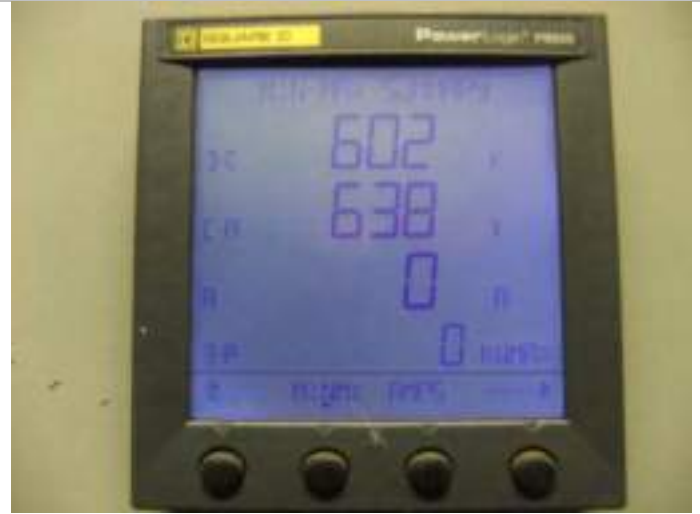
Photo 2: Current and power not indicating

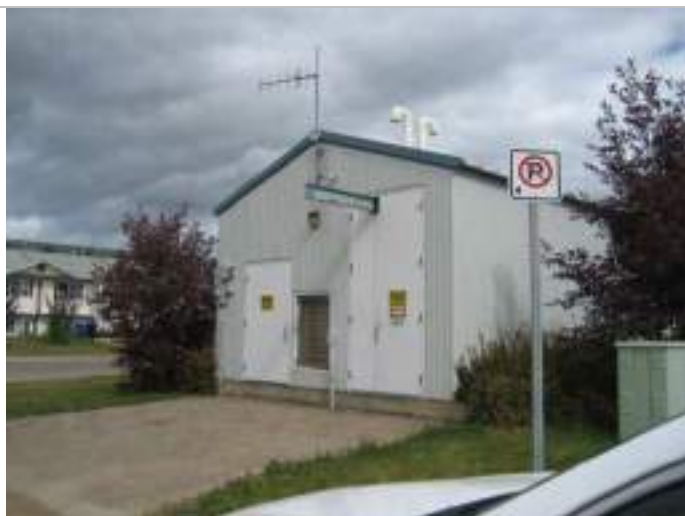
Photo 1: Front entrance to Dry Well and Wet Well.

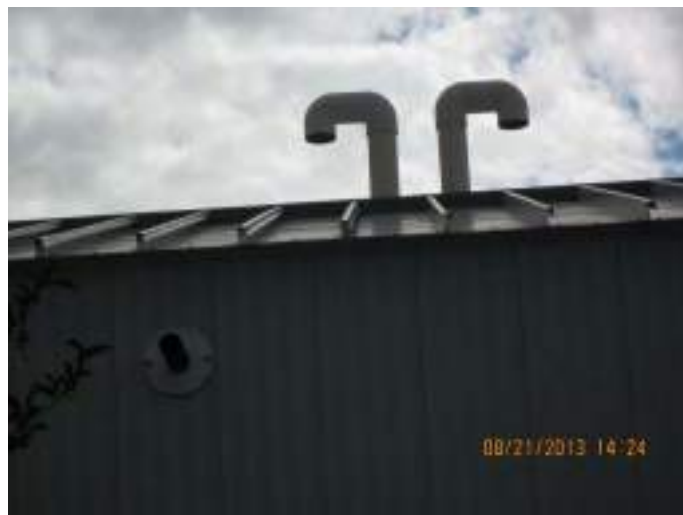
Photo 2: Standing seam roof in good condition.

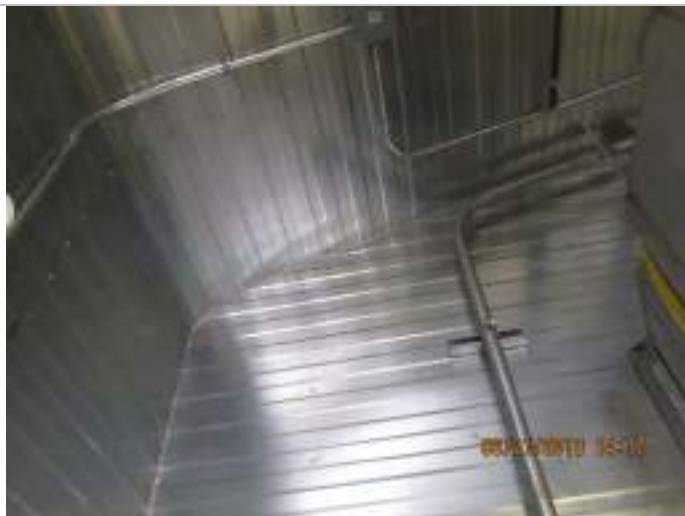
Photo 3: Interior wall and ceiling panels in good condition.

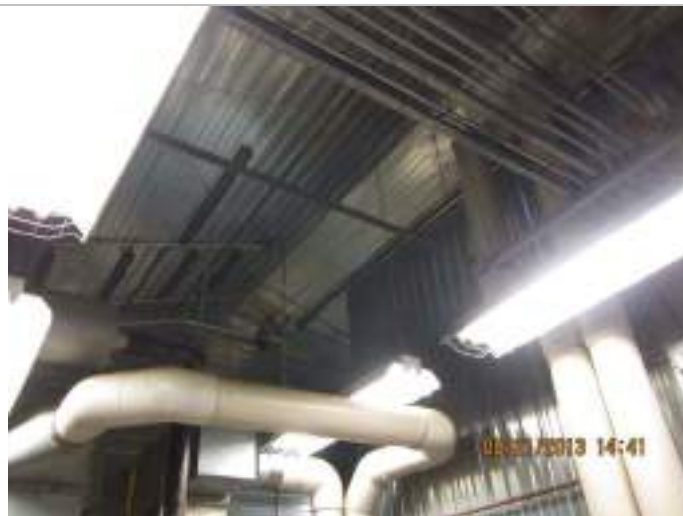
Photo 4: Interior of building on Dry Well side in good condition.

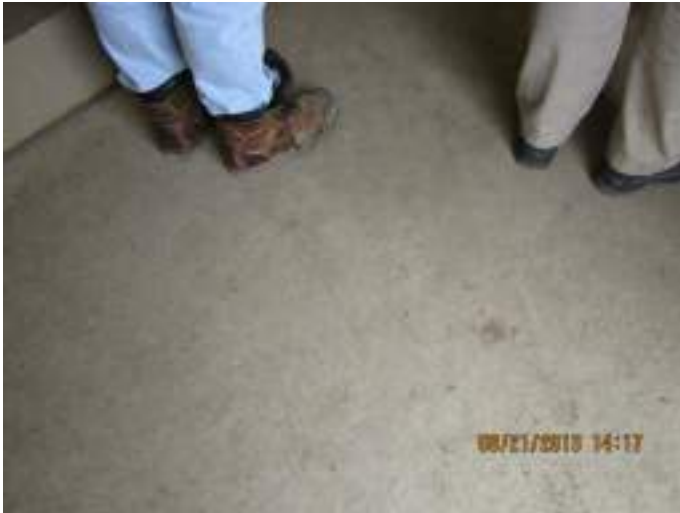
Photo 5: Crack in main floor concrete floor slab on Dry Well side to be sealed.

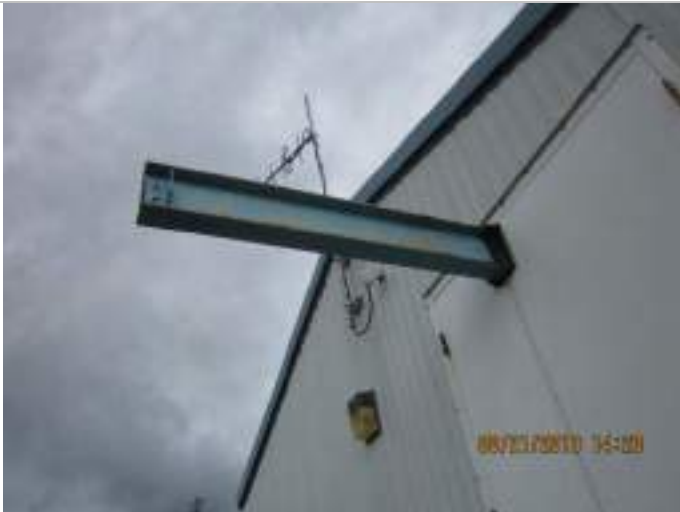
Photo 7: Monorail beam is corroded where it extends outside through door. Clean with wire brush and re-paint.

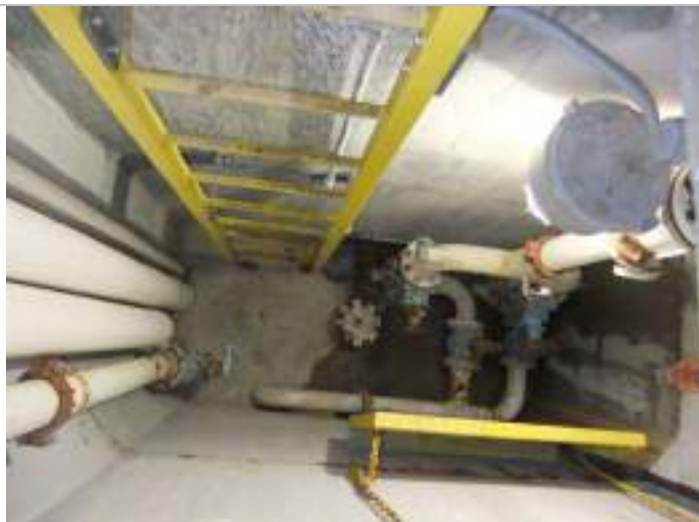
Photo 1: Restricted access into dry pit.

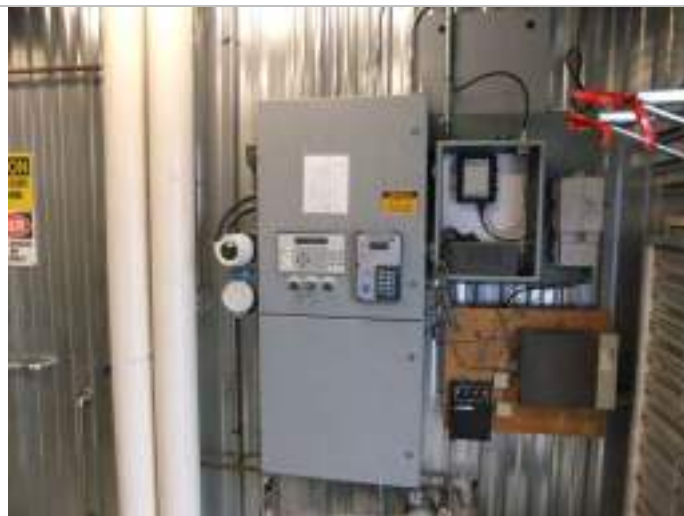
Photo 2: XBT Magelis controller (obsolete and broken buttons) and communication panel without door.

1. The DC power supply appears to be older and could be easily replaced. This would improve the availability of the PLC.
2. The PLC and HMI are at the end of life and should be replaced to The Municipality standard Modicon Quantum.
3. The Flygt bulbs could have an intrinsically save relay installed, Flygt makes one with a built in relay.
4. The leased line can be removed if the radio tower has proven reliable.
5. Clean out and maintain transformer and MCC.

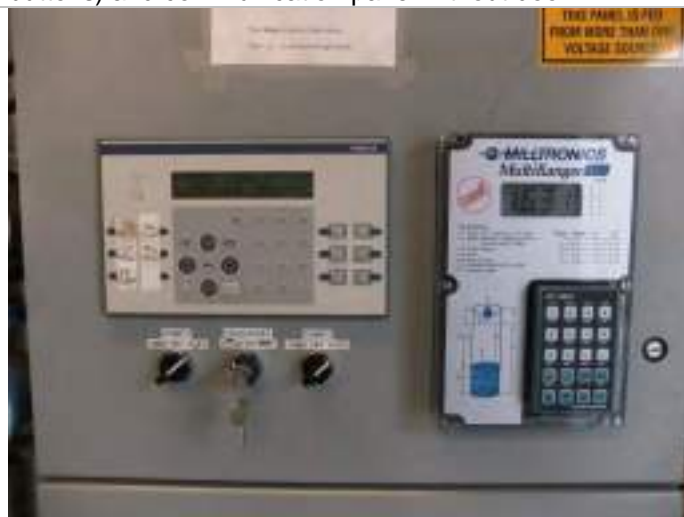
Photo 4: Control panel (buttons are damaged) Multi-ranger is in good working order.

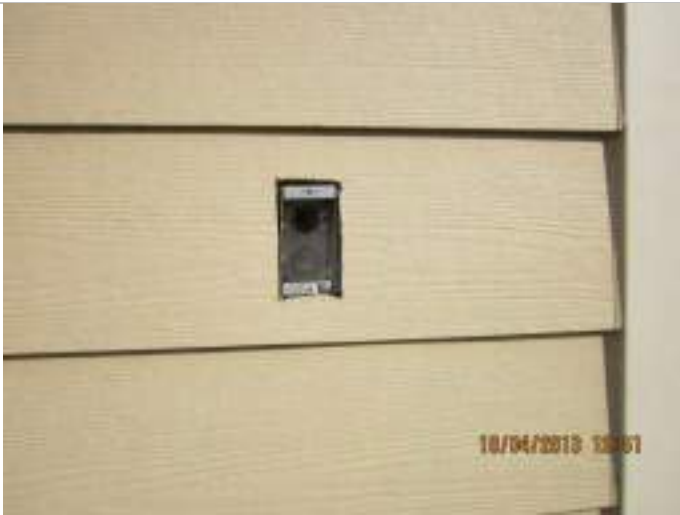
There are two electrical outlet boxes in the front exterior wall that are unfinished and exposed to the elements. There is exposed fiber board and insulation at the foundation level around the perimeter of the building that is deteriorating. The stone and mortar are cracking at the northwest corner of the outside wall. The exterior wood siding is damaged and deteriorating in several locations. The vertical section of siding trim has cracked at the northwest corner adjacent to the stone. The gas line that projects through the siding on the back wall is not caulked on the outside. The electrical cables that project through the block wall and siding on the southeast side is not sealed on the outside. There is a roughly cut opening on the outside wall that is caulked around the cables inside the building but the outside looks unfinished. The ceiling has been roughly cut and caulked where electrical cables pass through on the Dry Well side. The eaves trough downspout on the southeast corner is damaged and ends beside the foundation instead of directing water away from the building. A section of guardrail is missing at the south floor hatch on the Dry Well side. The Dry Well main floor concrete slab has been roughly patched in several locations and bolts have been cut off and left exposed in the slab. The 2 tonne monorail hoist in the Wet Well is tagged as last inspected on 01/09/2010 and is overdue for inspection. The 1 tonne monorail hoist on the Dry Well side is also due for inspection. There is no safety cage around the ladder down into the Wet Well, so a fall protection system is required for personnel to access the Wet Well using the ladder.

Photo 1: Exposed electrical outlet box on outside wall.

1. Finish the electrical work as required on the exterior outlet boxes and install covers.
2. Install flashing or siding to protect the fiber board and insulation at the foundation along the perimeter of the building. Replace damaged fiber board and insulation as required.

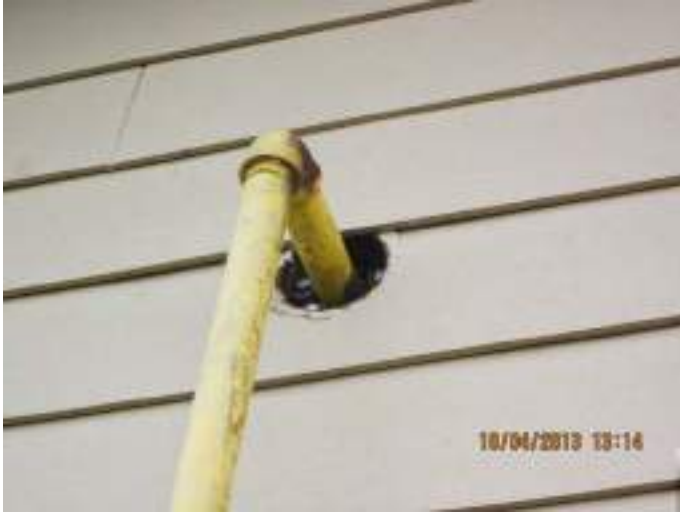
Photo 5: Caulk siding around gas line.

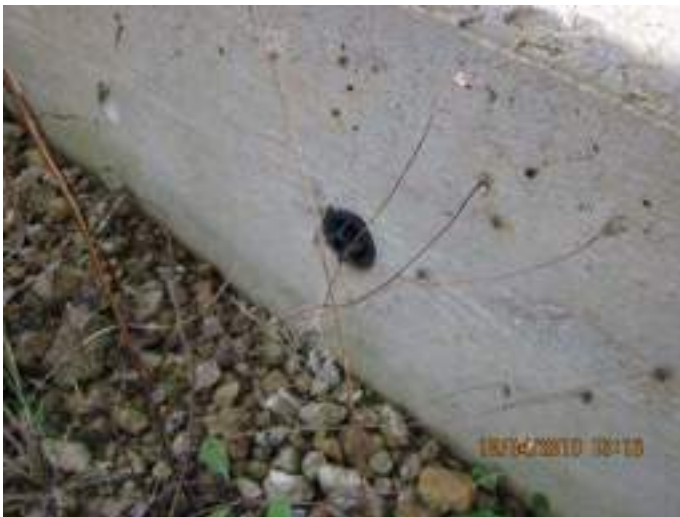
Photo 7: Remove form tie former and patch at antennae foundation.

16. Remove plastic form tie formers in the antennae concrete foundation and patch voids with an approved cementaceous repair grout.
17. Chip out unsound concrete that has spalled on the generator foundation slab and patch with an approved cementaceous repair grout.

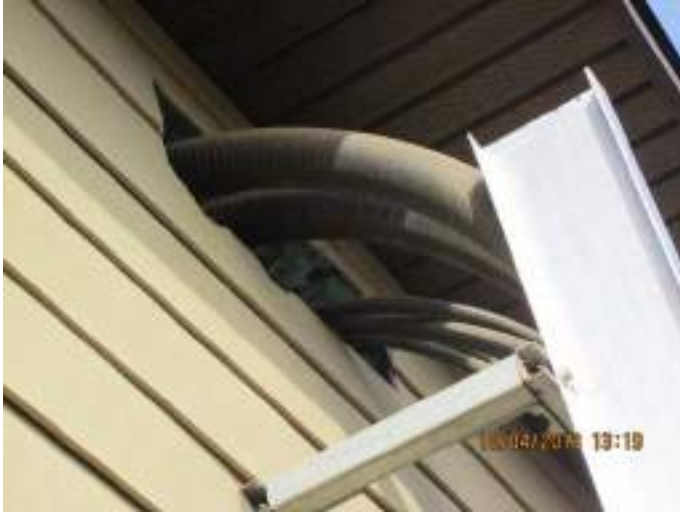
Photo 9: Install cover or seal siding where electrical cables enter at southeast corner.

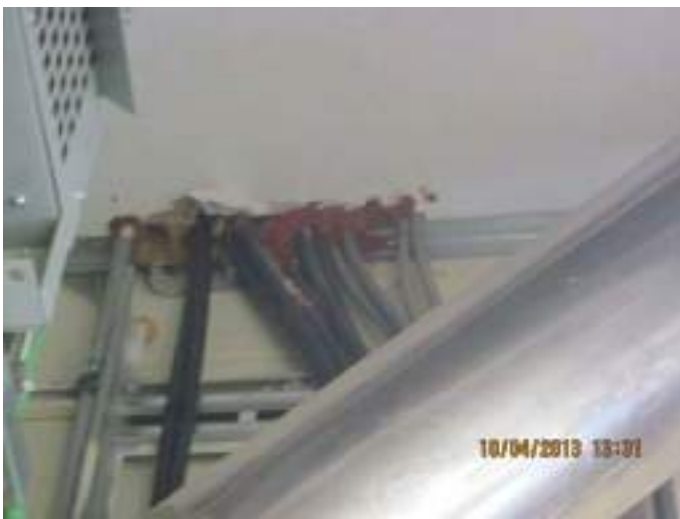
Photo 11: Repair ceiling and re-caulk where electrical cables enter ceiling.

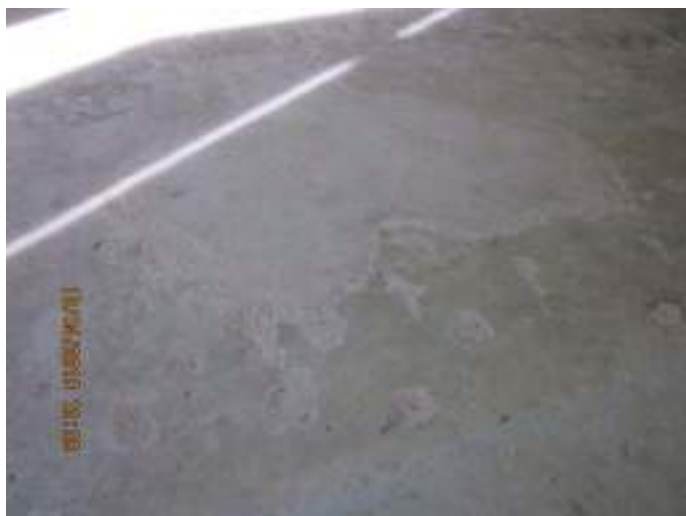
Photo 13: Patches in the Dry Well main floor concrete slab.

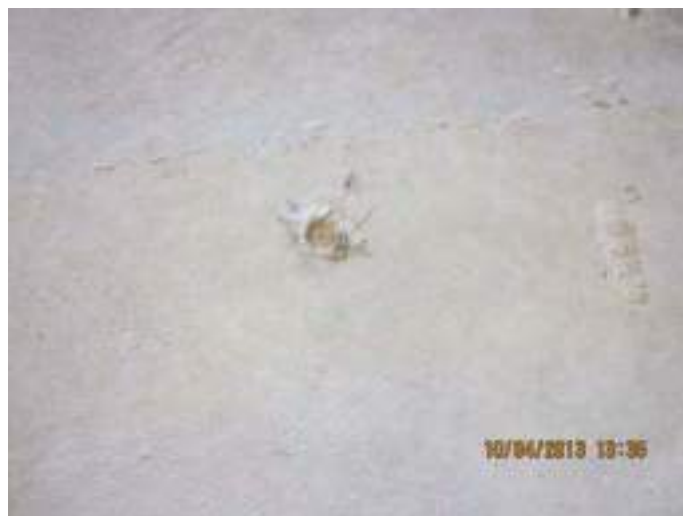
Photo 14: Bolt cut off and exposed in the Dry Well main floor concrete slab.

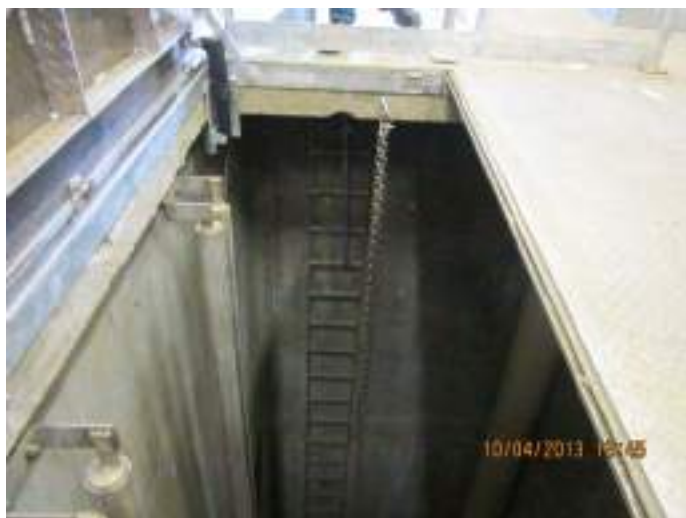
Photo 15: Access ladder down into the Wet Well with no safety cage. Fall protection is needed to enter on the ladder.

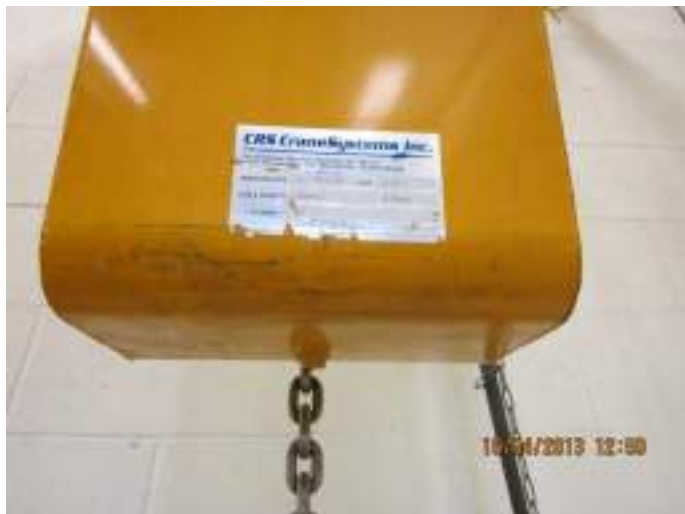
Photo 17: 2 tonne monorail hoist certification has expired according to inspection sticker.

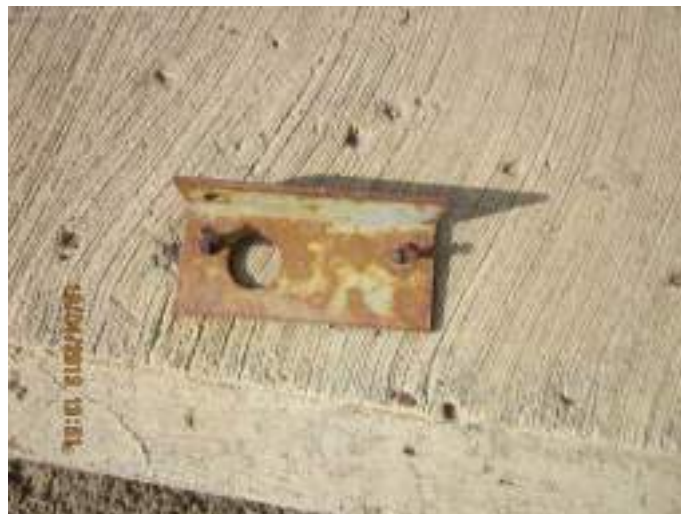
The door stop on the Wet Well concrete apron slab is a steel angle that is corroded and is fastened to the slab with nails that project above the angle. The molding at the inside bottom of the Dry Well entrance door is bent. There is concrete and steel debris on the ground at the southeast corner of the building that is a trip hazard. The plastic form tie pocket formers in the antennae concrete foundation have not been stripped out and patched. The generator concrete slab is spalling on the west side of the slab.

Photo 18: Door stop angle has corroded and is fastened to the apron slab with nails at Dry Well.

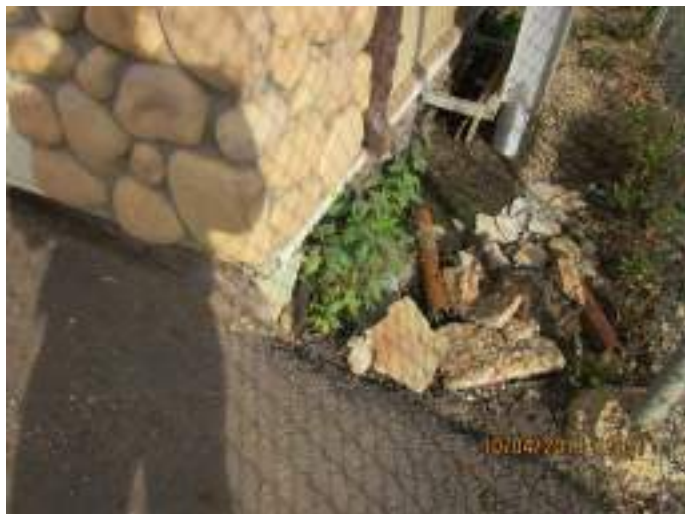
Photo 19: Concrete and steel debris is trip hazard at southeast corner.

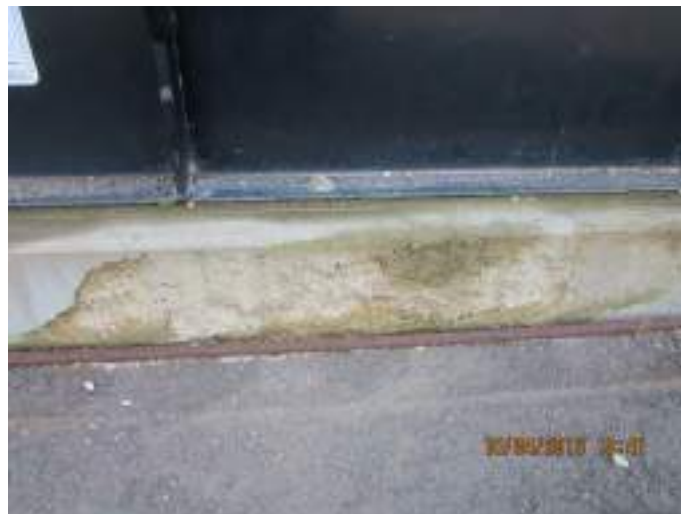
Photo 20: Generator concrete slab is spalling and needs repair.

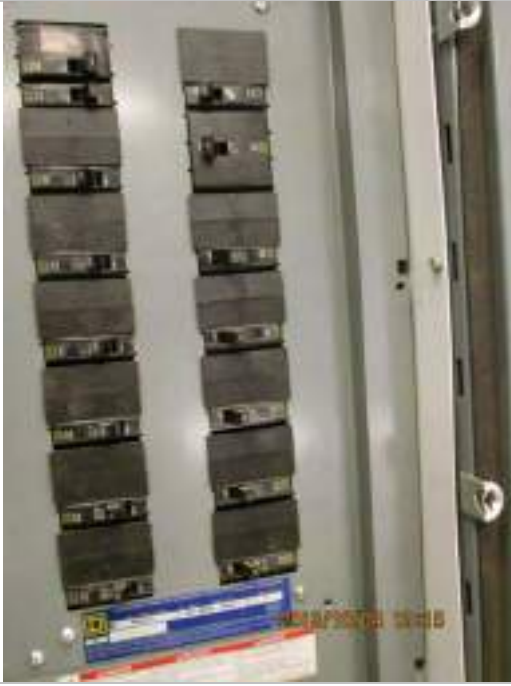
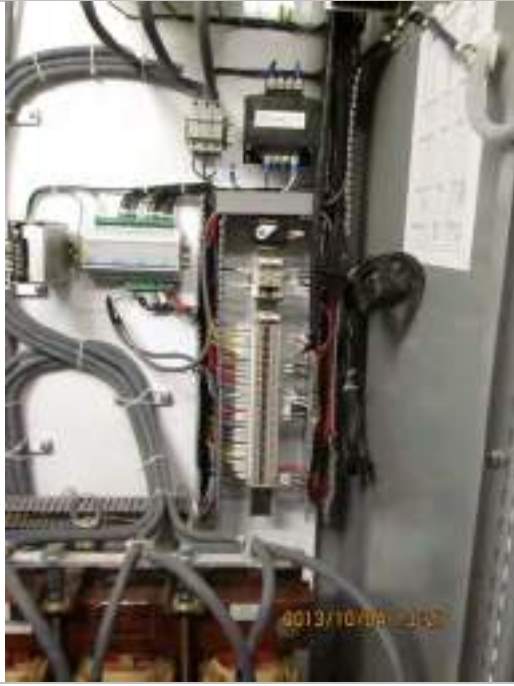
<p><i>Some equipment, including Panelboard B was not labelled.</i></p>	<p><i>Panduit missing from VFD cubicles</i></p>

- Tidy up wiring in transfer switch panel
- Replace missing Panduit in VFD starters as necessary.
- Provide supports on VFD enclosure isolator handles.
- Ensure Code Compliance with Canadian Electrical Code Part 1 section 18 and section 22-700
- Confirm hoist is suitable for Class 1, Zone 2 area.

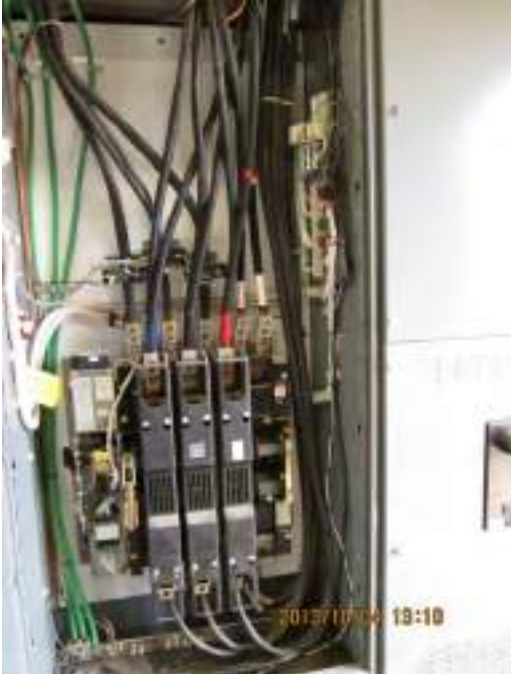
<p><i>Transfer switch interlinking cables have not been installed properly.</i></p>

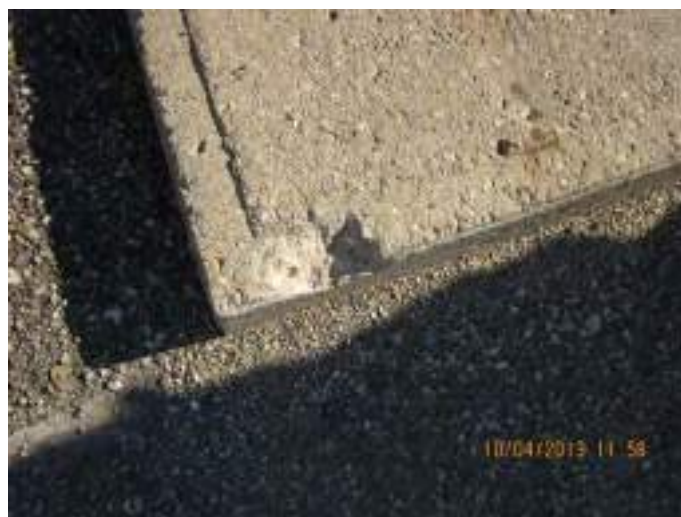
Photo 4: Spall in Dry well apron slab.

1. Replace the missing letters from the station identification sign.
2. Patch the spall in the Dry Well apron slab to eliminate trip hazard and stop further spalling.
3. Remove peeling paint and re-paint flashing, Dry Well steel door, and graffiti on Wet Well steel door.
4. Re-seal the cracks in the joint of the masonry block wall in the Dry Well.
5. Have the monorail crane inspected by a certified crane inspector and mark the Safe Working Load on the monorail beam.
6. Ensure a fall protection system is in place when personnel are using the ladder to access the Wet Well.

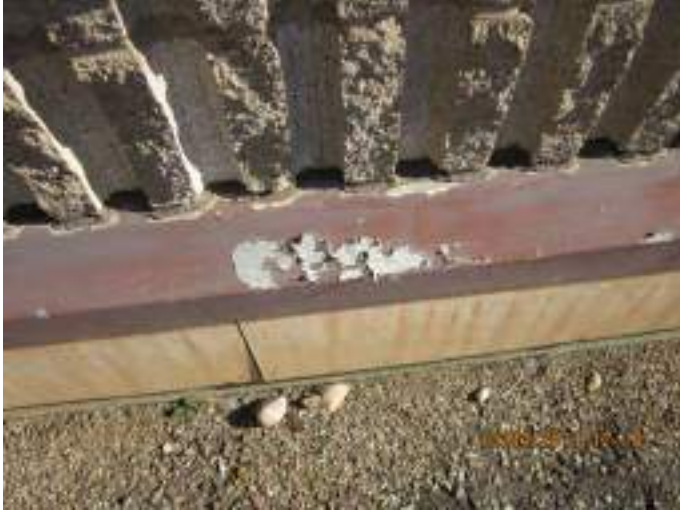
Photo 5: Paint peeling off metal wall flashing.

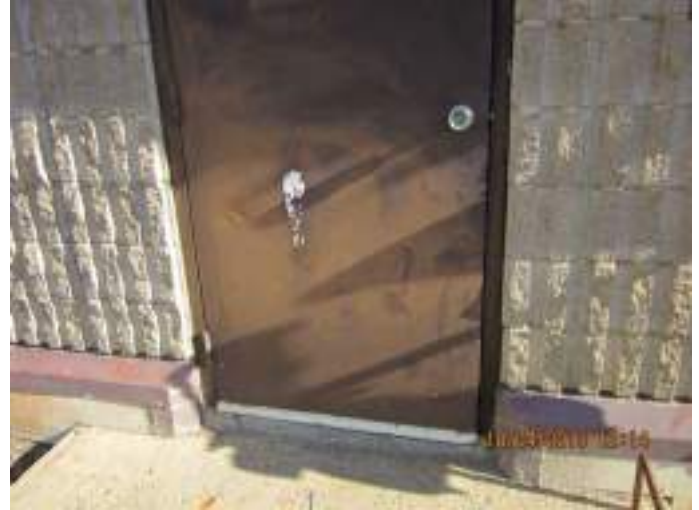
Photo 6: Paint peeling off Dry Well steel door.

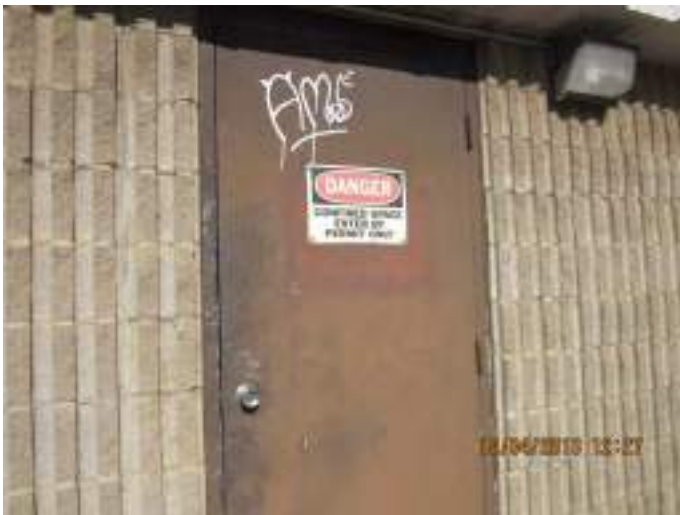
Photo 7: Graffiti on Wet Well steel door.

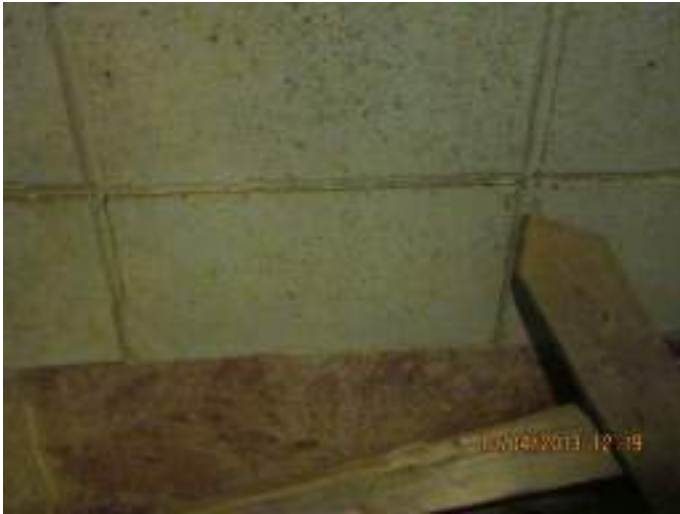
Photo 9: Cracks in joints of masonry block wall in Wet Well.

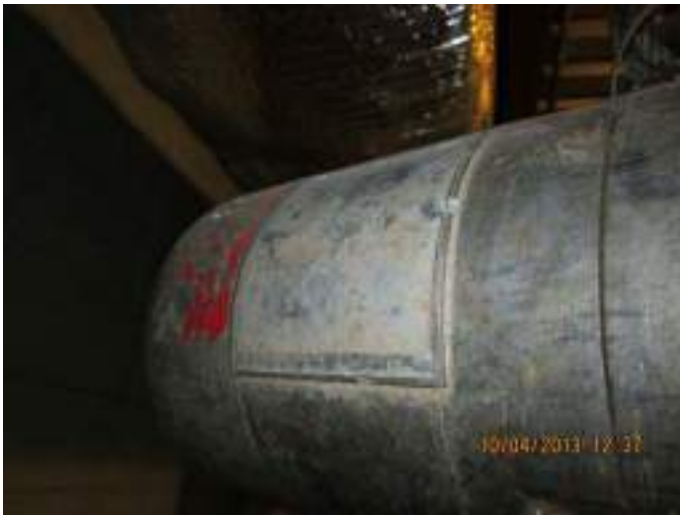
Photo 11: 1/2 ton monorail hoist missing manufacturers label.

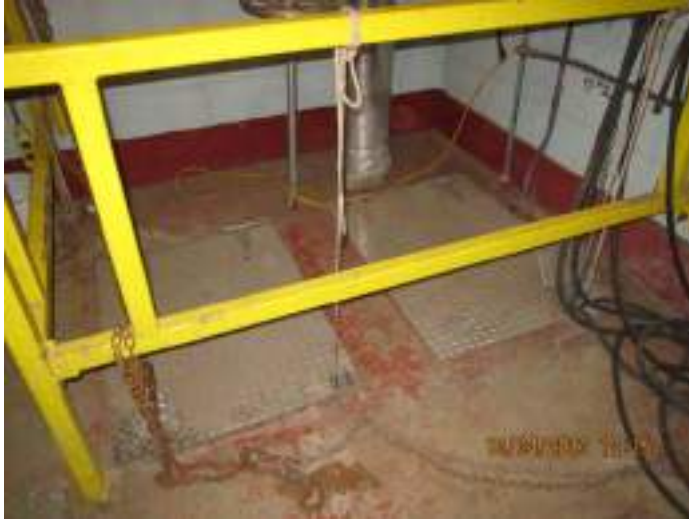
Photo 1: Wet well access.

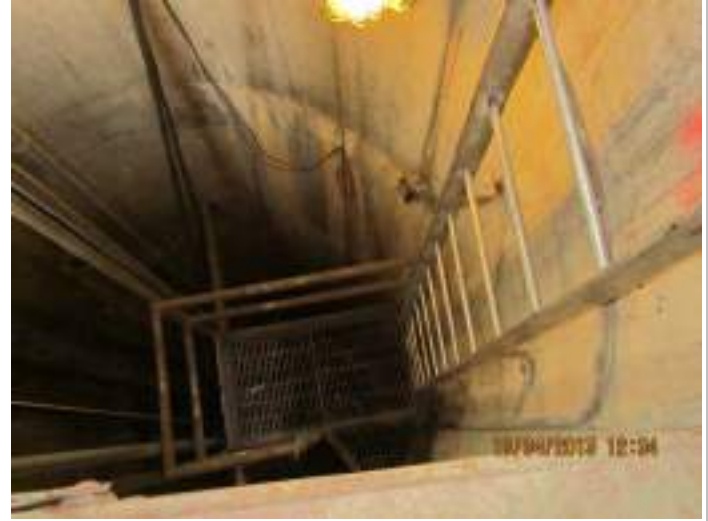
Photo 2: Wet well – intermediate landing.

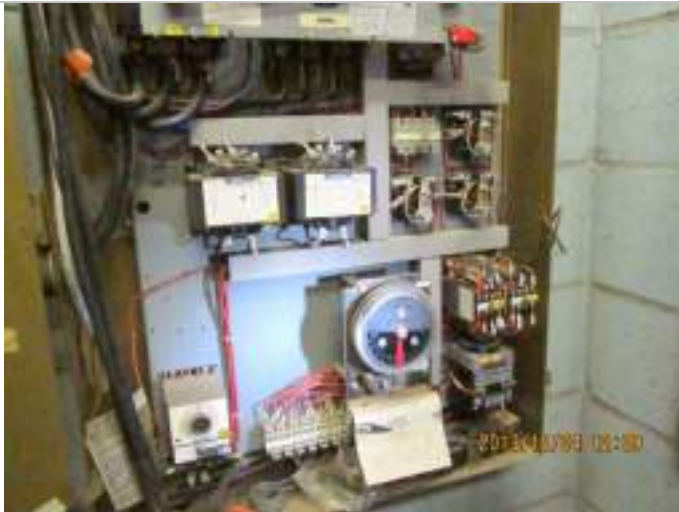
Transfer panel is old and is most probably unreliable and difficult to maintain.

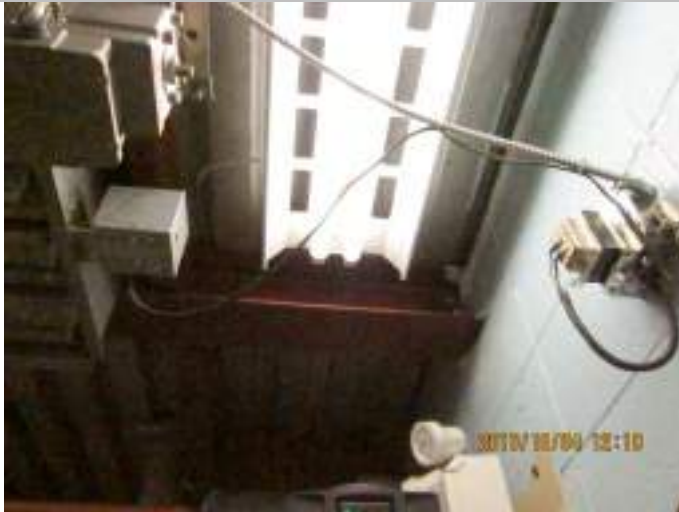
Some cables to the H&V system are not mechanically protected.

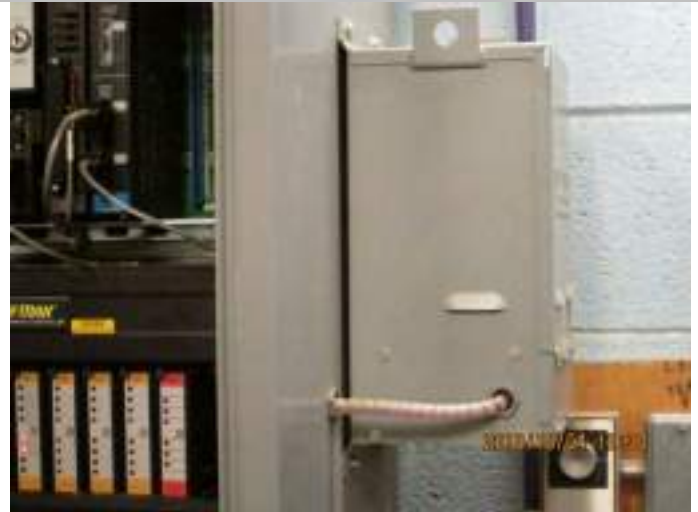
Some cables into the PLC panel are not mechanically protected.

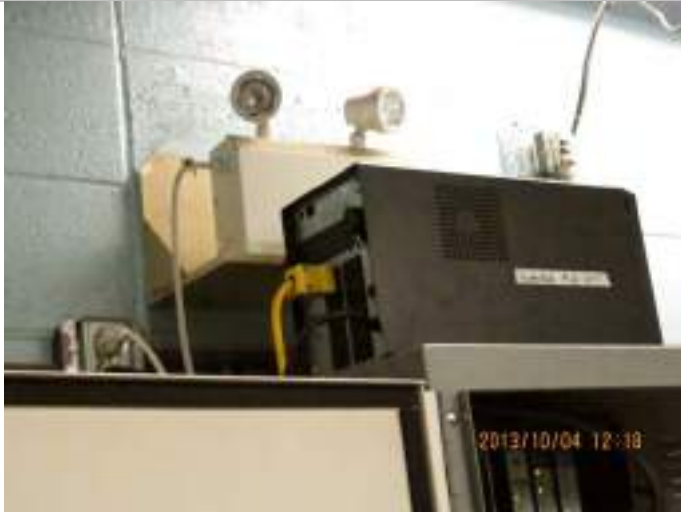
Space is at a premium and the UPS is on top of the PLC panel

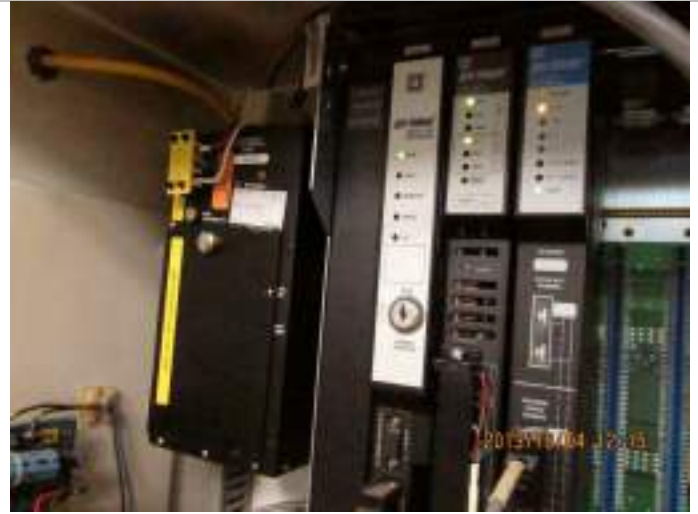
The Symax 300 PLC processor power supply temperature was detected at 50 degC. This is high for an electronic component but no burning was seen on the exterior.

The Symax 300 PLC power supply temperature was detected at 50 degC

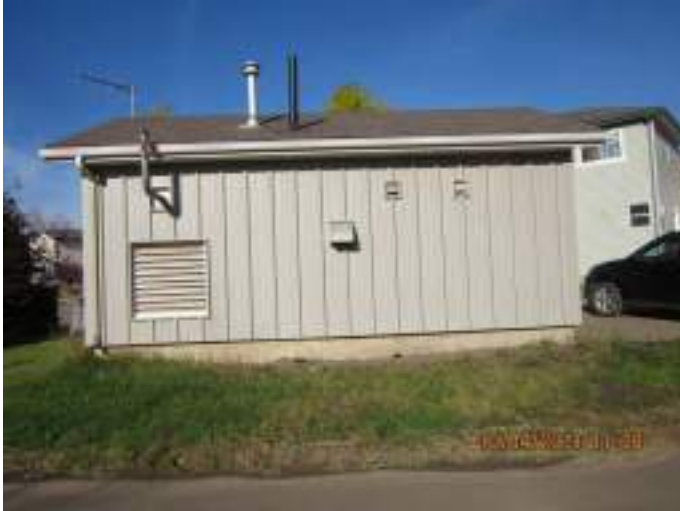
The concrete foundation has voids and segregation on the east and west sides at the ground level. There is corrosion on the generator exhaust pipe where it exits the building on the east wall. There are several large shrinkage cracks in the concrete in main floor slab and paint is peeling off of the slab. The metal molding on the inside of the door at the bottom is bent. The monorail is overdue for inspection with the next inspection date of 29/04/13 on the inspection sticker. There is no safety cage around the ladder down into the Wet Well so a fall protection system is required for personnel to access the Wet Well.

Photo 1: East side of building with voids and segregation of concrete foundation.

1. Patch the voids and segregation in the concrete foundations with an approved cementaceous repair grout to prevent further deterioration and keep small rodents out.
2. Remove corrosion from the generator exhaust pipe and protect the exposed metal with an approved material that can withstand the heat being generated.
3. Seal the shrinkage cracks in the concrete floor slab with an approved concrete floor sealer. Do paint touch-ups where paint is peeling off of the concrete floor slab.
4. Screw the bent metal molding back onto the door at the bottom on the inside or replace it completely.
5. Have the monorail crane inspected by a certified inspector as it is overdue for an inspection according to the inspection sticker.
6. Ensure a fall protection system is in place when personnel are using the ladder rungs to access the Wet Well.

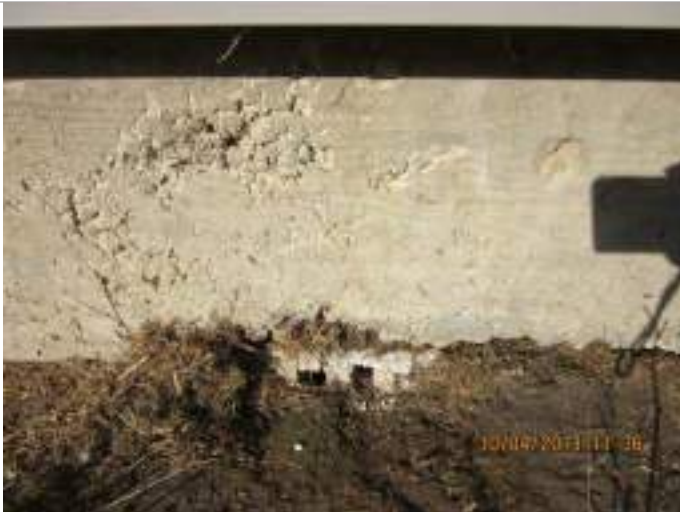
Photo 3: Voids and segregation in concrete foundation.

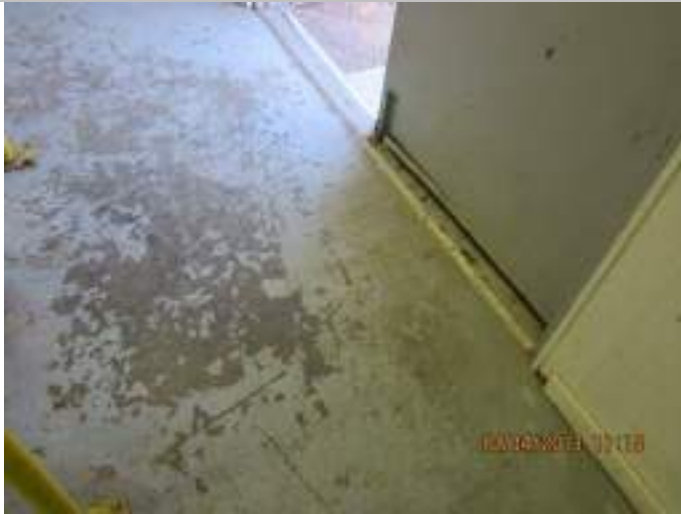
Photo 5: Paint is peeling off of main floor concrete slab.

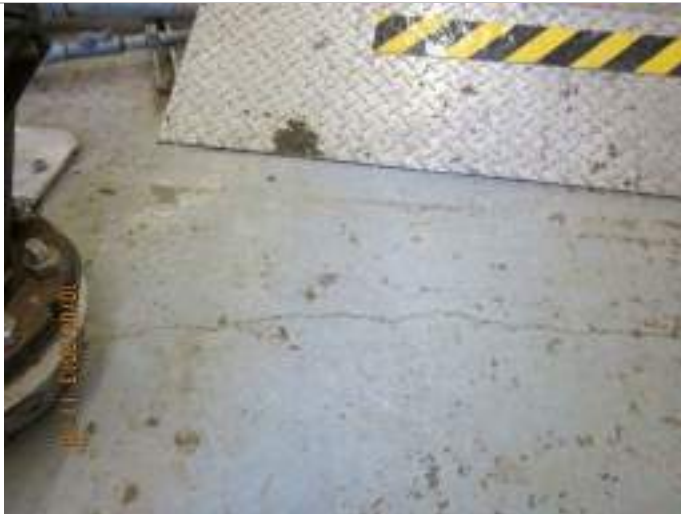
Photo 7: Crack in main floor concrete floor slab.

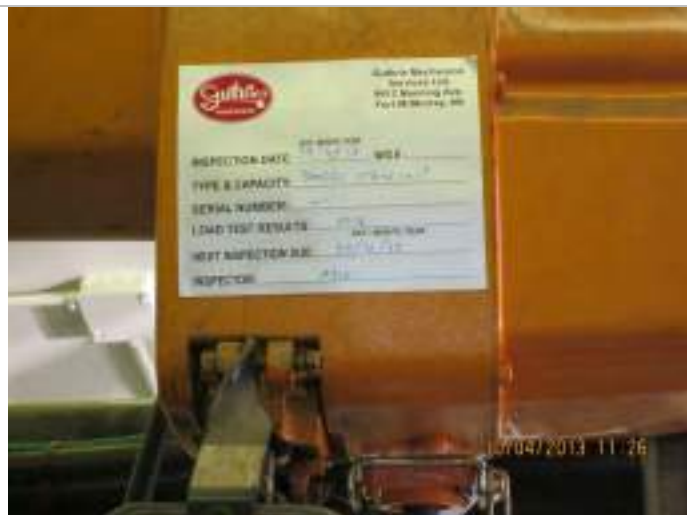
Photo 9: Monorail inspection sticker indicates inspection is overdue.

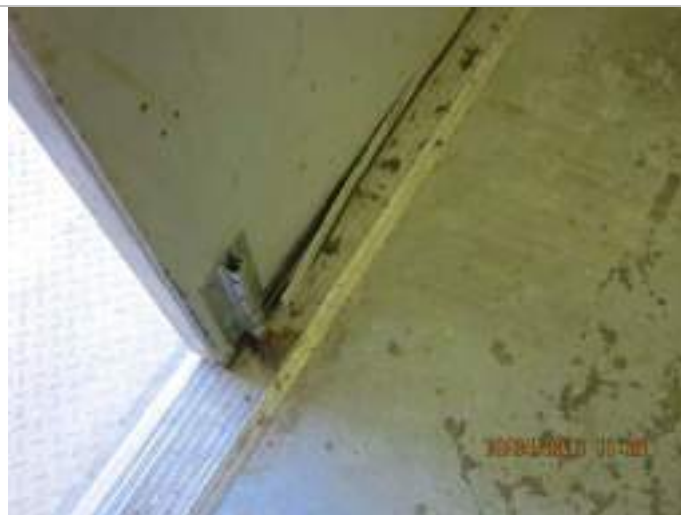
Photo 10: Bent molding on the inside of the door at the bottom.
