TECHNICAL MEMORANDUM B.1.5

Regional Municipality of Wood Buffalo

Wastewater Collection System Master Plan

Hydraulic Model and Design Criteria Update

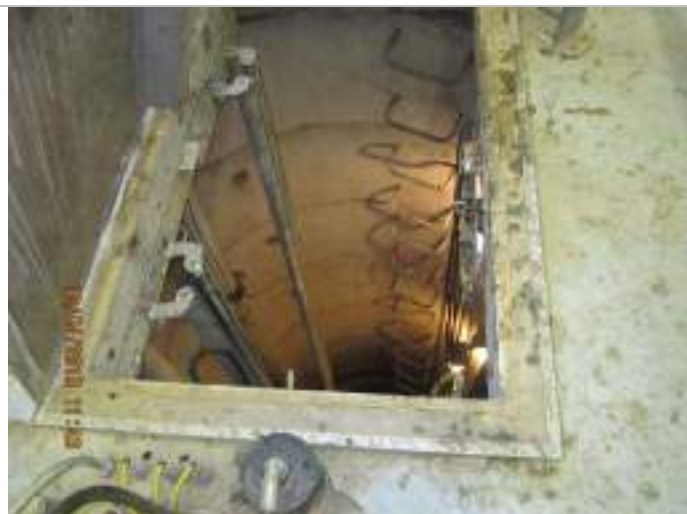
Photo 11: Wet Well access hatch. Use Fall Protection System to access Wet Well using ladder rungs.

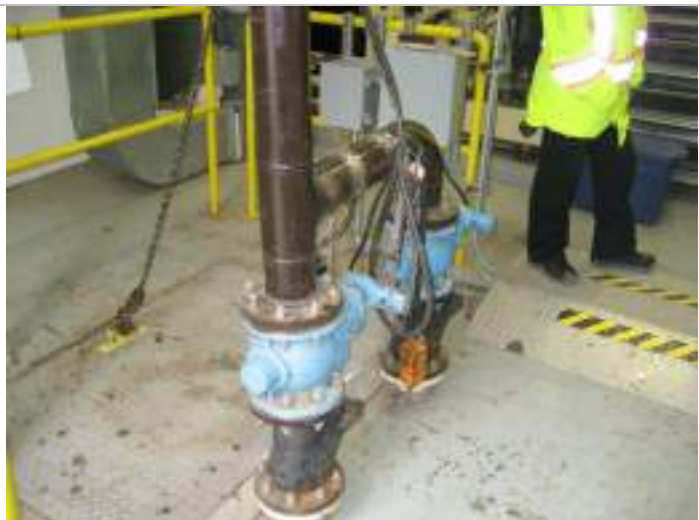
Photo 1: Discharge valves piping, above wet well access.

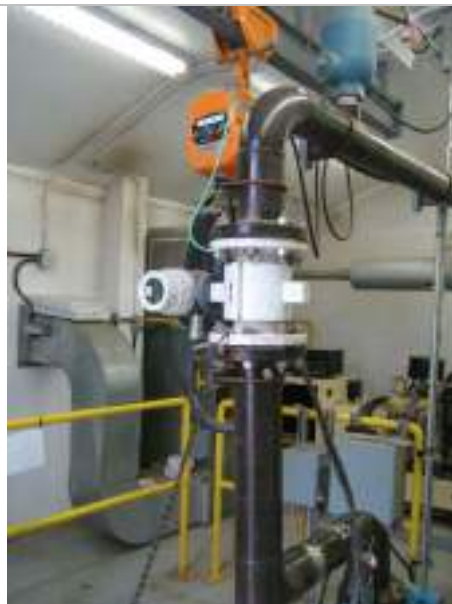
Photo 2: Discharge piping, flow meter.

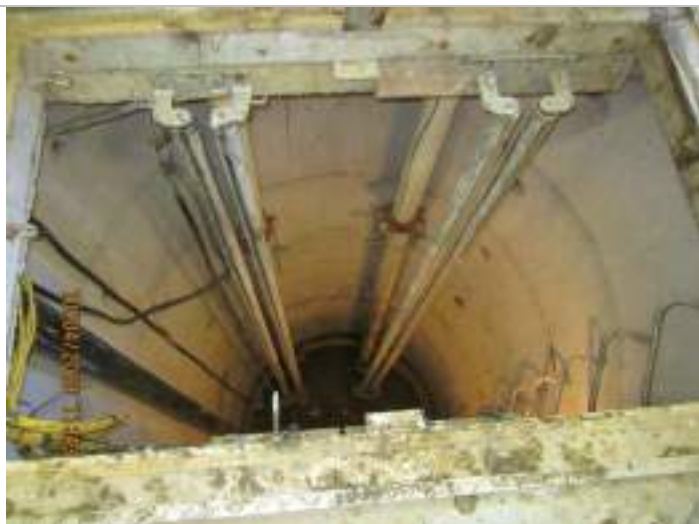
Photo 3: Wet well.

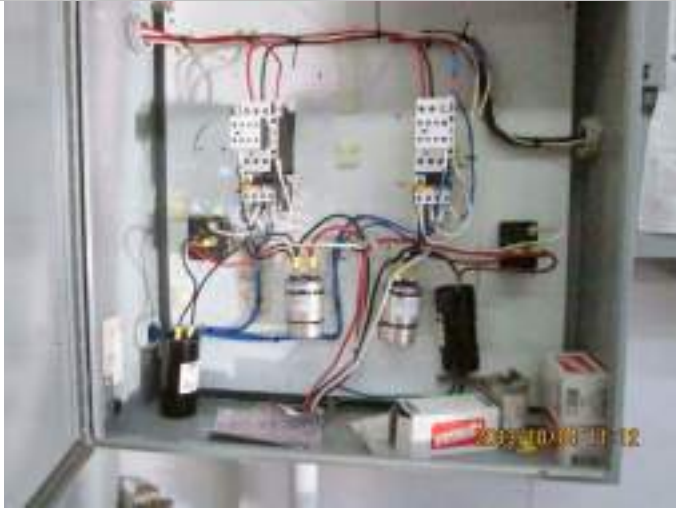
Pump starter panel is not fabricated well and supplies run through this cabinet to the PLC cabinet. There is evidence of previous capacitor failure with burnt cables and debris present.

The pump panel requires rebuilding and maintenance to ensure reliability.

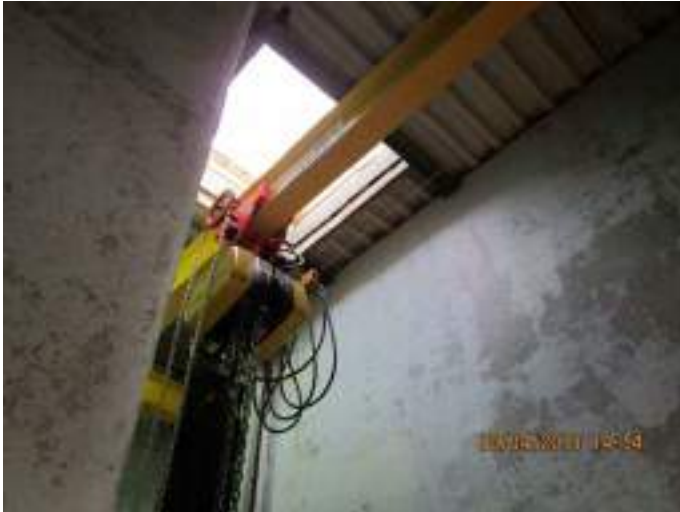
Photo 1: Monorail crane SN 1250-1 over the Wet Well. The rated capacity and inspection sticker are not visible.

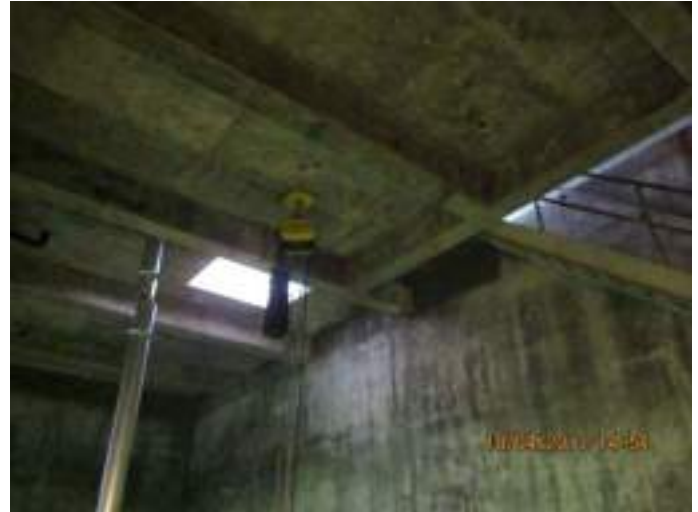
Photo 2: Hoist in Wet Well mounted to underside of main floor slab was being used to service equipment. The rated capacity and inspection sticker are not visible.

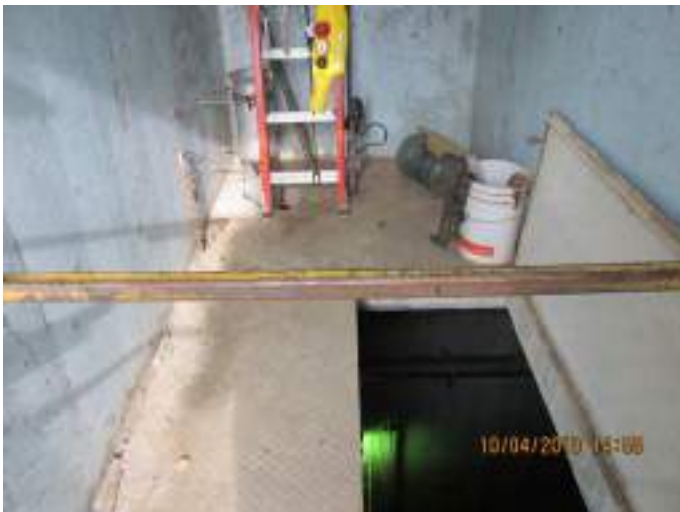
Photo 3: Cover the oversized pipe opening to prevent things falling into the Wet Well.

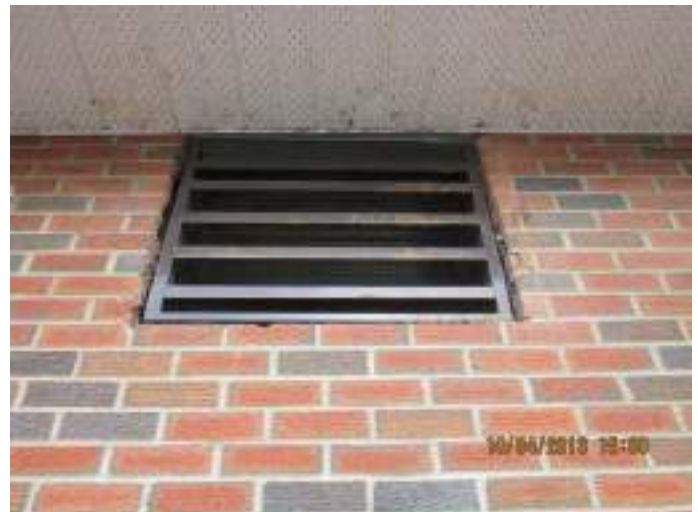
Photo 4: Caulk the gap between the louver and the brick near the entrance to the Wet Well.

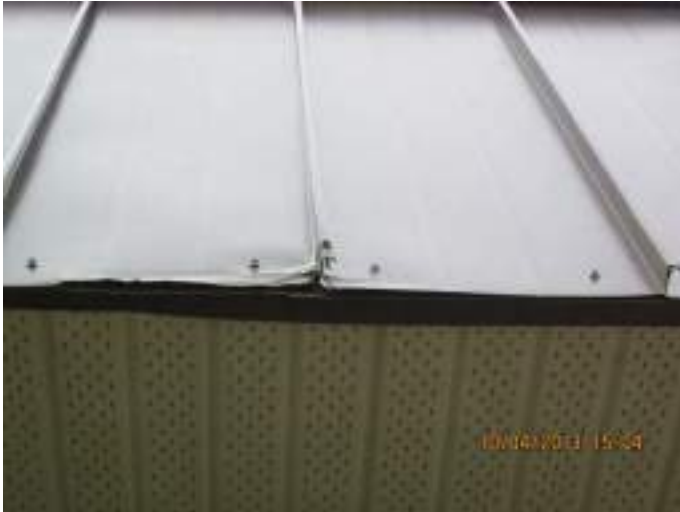
Photo 5: Repair the damaged metal siding on the north side.

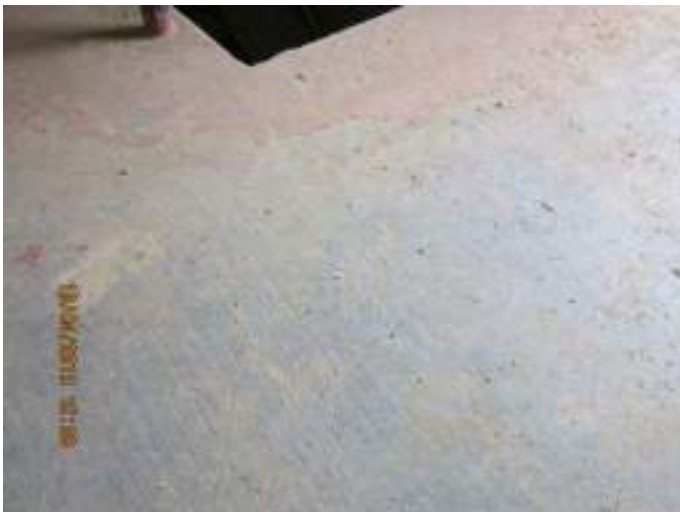
Photo 7: Shrinkage cracks in the Dry Well main floor slab near the stair opening.

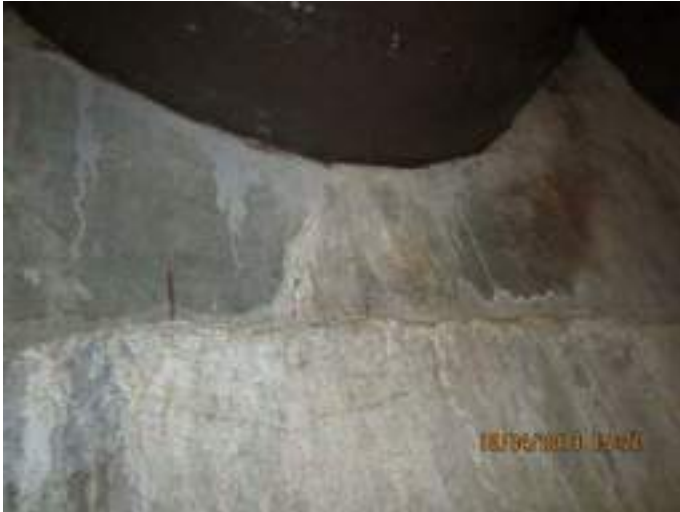
Photo 9: Shrinkage cracks in the Wet Well wall where a pipe passes through the wall.

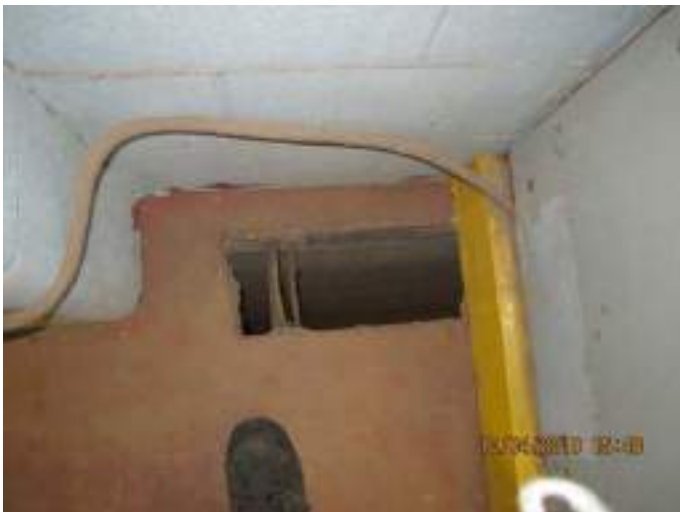
Photo 11: Opening in the main floor slab of the Dry Well where things can fall through into the Dry Well.

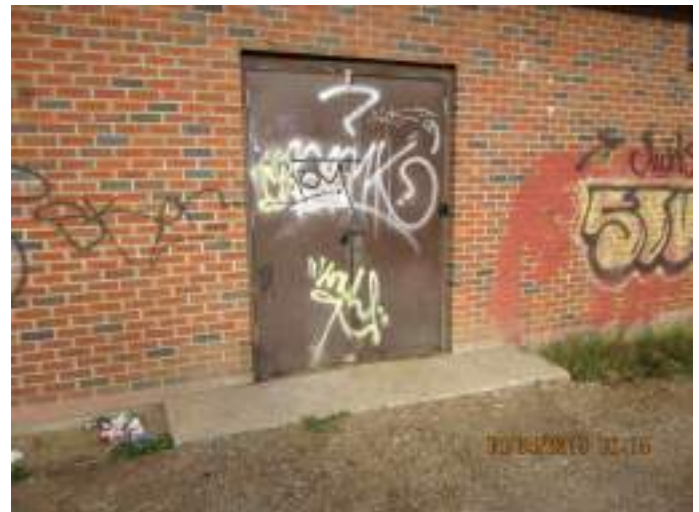
Photo 12: Graffiti on the Wet Well doors and brick wall.

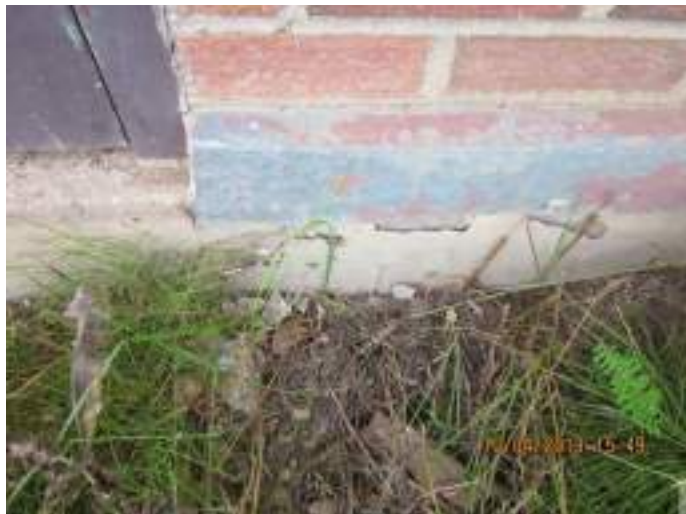
Photo 13: The concrete foundation is spalling on the north side near the double doors.

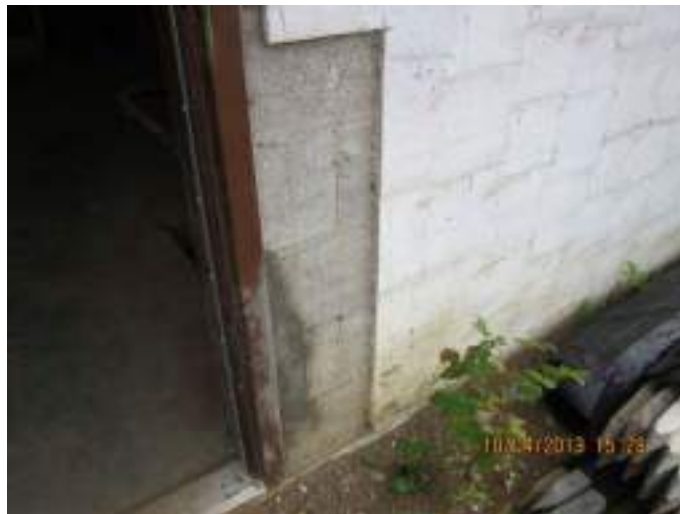
Photo 14: Parging has been removed on the outside wall near the door to the Dry Well.

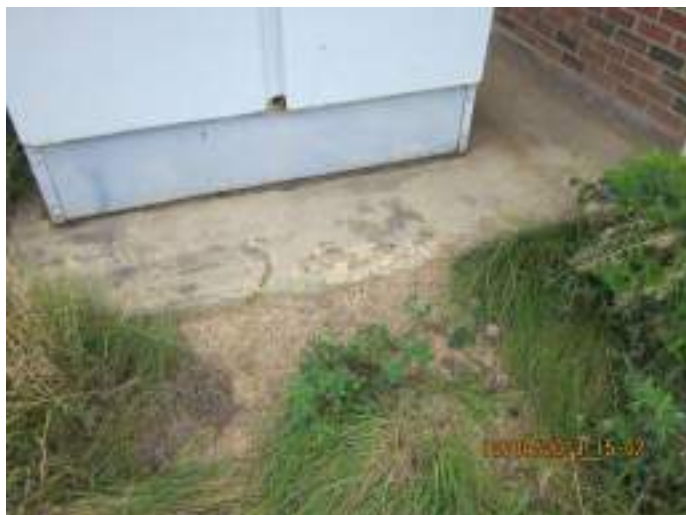
Photo 15: Concrete is spalling off a cabinet foundation on the north side of the building.

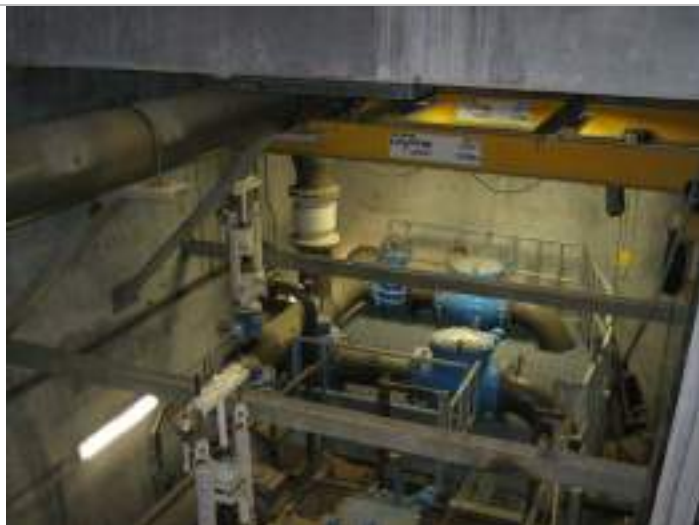
Photo 1: Dry well - discharge valves and piping.

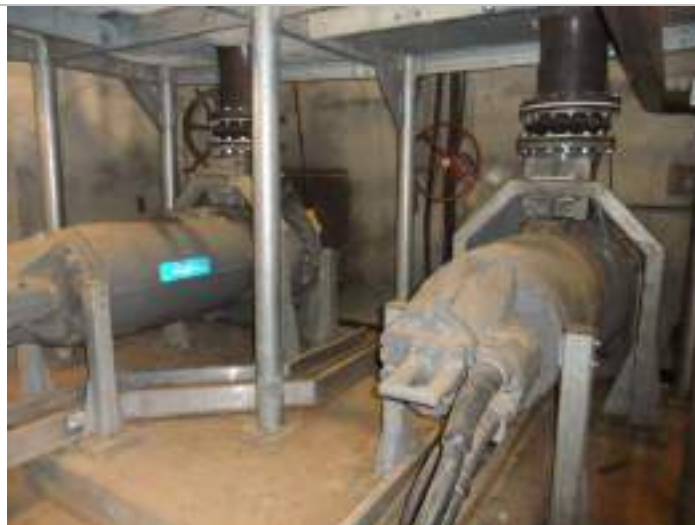
Photo 2: Two new pumps (P-003 & P-004) & piping.

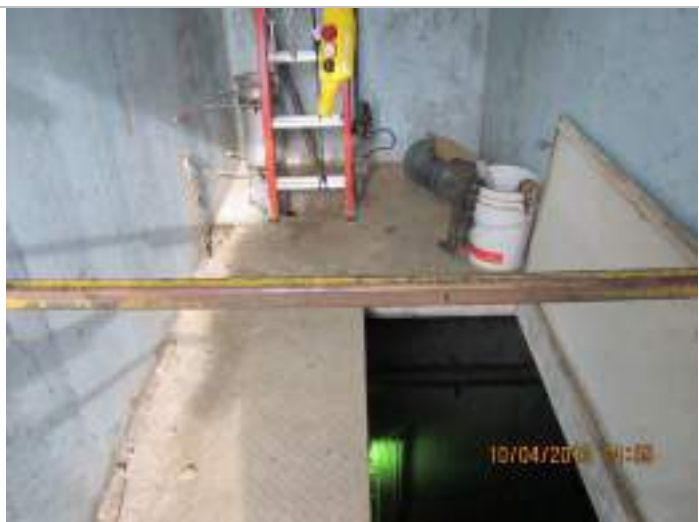
Photo 3: Wet well access.

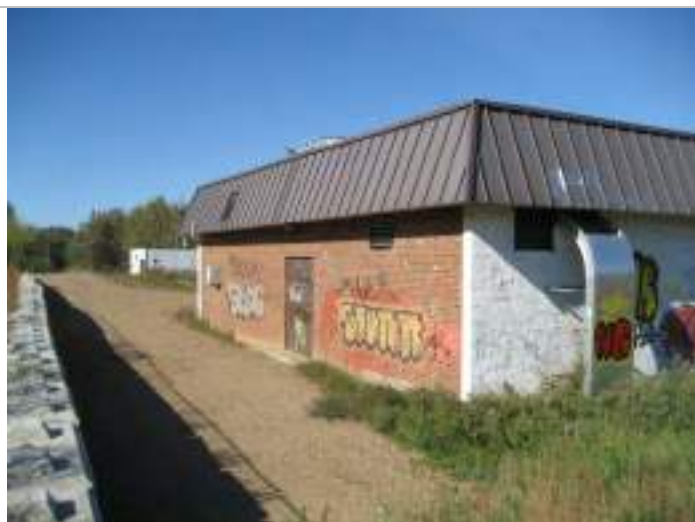
Photo 4: Pump house exterior, showing berm at left.

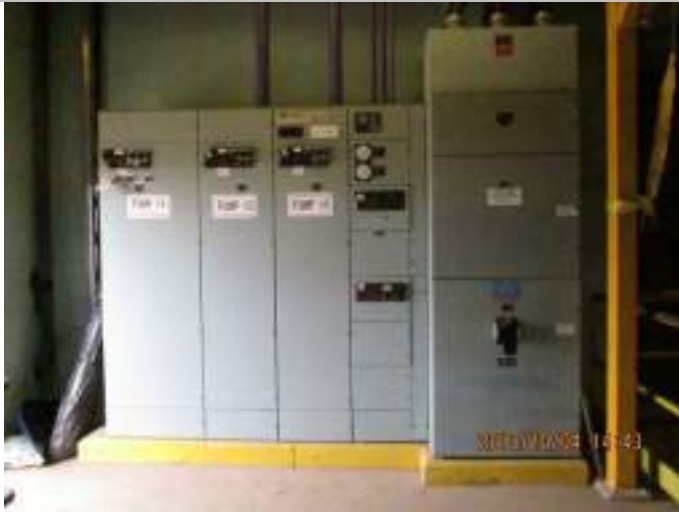
All 480VAC equipment seems to be approaching end of life.

- Install intrinsically safe barriers on level switches.
- Consider replacement of 480VAC installation
- If SOW cables are can be subject to mechanical damage then provide mechanical protection higher than 5'
- Replace light fittings
- Undertake detailed inspection and preventative maintenance on all electrical equipment.

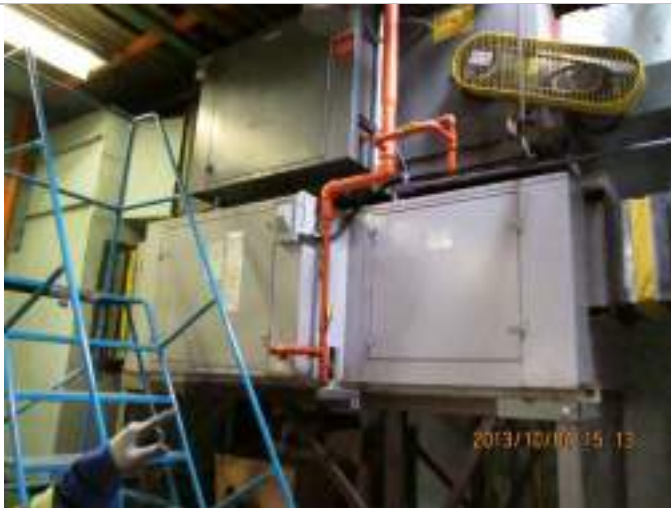
All equipment including heaters, lights and other equipment to be labelled stating point of supply and voltage.

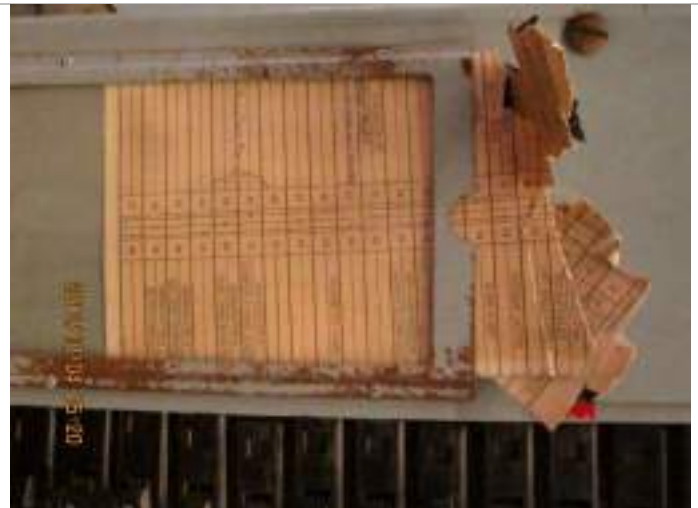
All panelboards supplies to be identified.

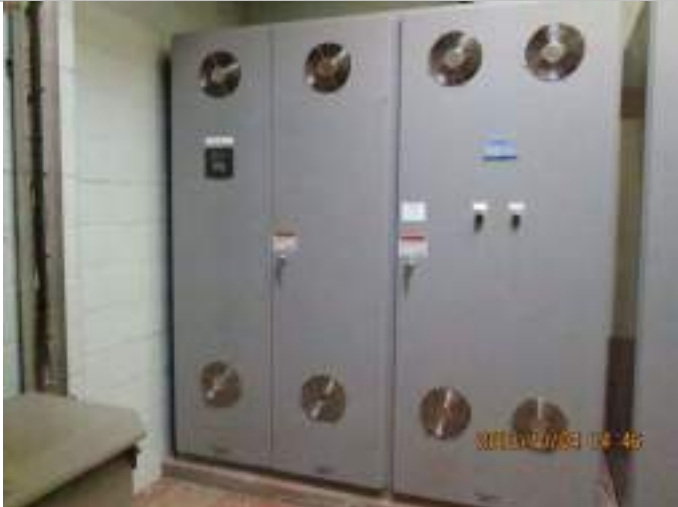
<p>VFD ventilation filters to be cleaned.</p>

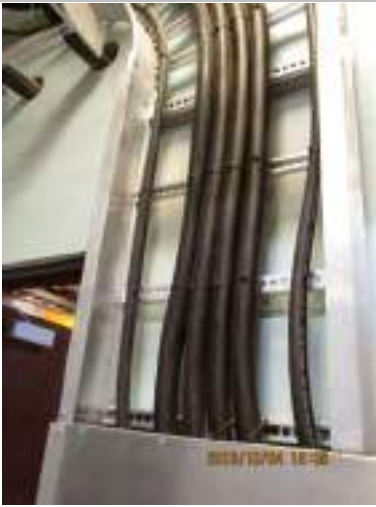
<p>Consider protection of SOW cables in new MCC room</p>

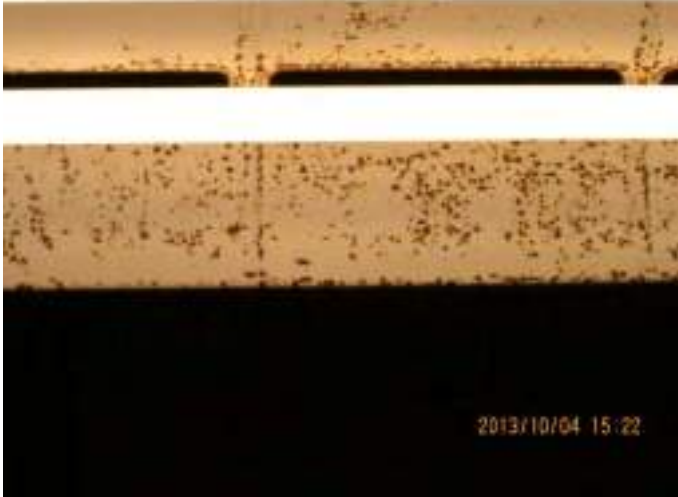
Light fittings rusted. This may indicate that electrical equipment generally has been subject to humid conditions that would shorten the life expectancy.

<p>Light fittings rusted</p>

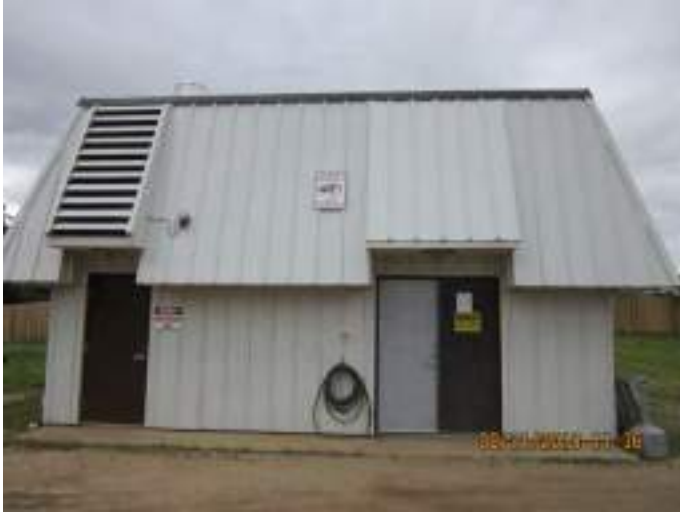
The reinforced concrete apron slab at the front entrance doors is in poor condition. There is a major crack in the slab at the SW corner near the Wet Well entrance. There is a large spall in the apron slab in front of the Dry Well entrance. Both should be repaired.

Photo 1: Front entrances of Cornwall Sewage Lift Station. The apron slab has spalls and cracks that need repair.

1. Paint the ends of the bolts that were cut off in the Dry Well walls to prevent corrosion in the future.
2. Monitor wall parging in the Wet Well to see if it continues to fall off with time.
3. Repair the crack and spall in the apron slab at the door entrances.
4. Sand and re-paint the wood slats at the underside of the louvers.
5. Clean the dust and debris from the vent in the ceiling at the entrance to the Wet Well.

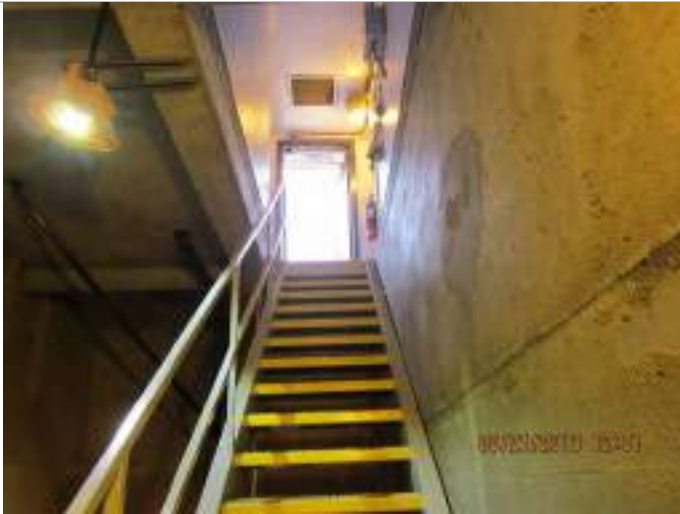
Photo 3: Parging on Wet Well concrete wall is peeling off.

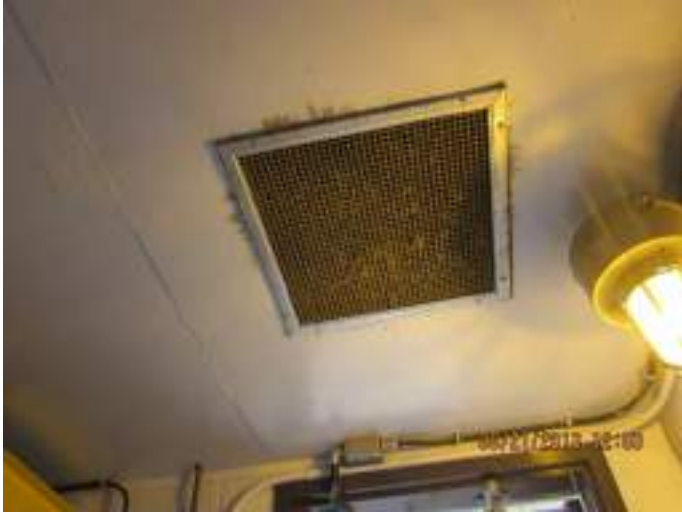
Photo 5: The Wet Well ceiling vent is clogging with dust and debris and requires cleaning.

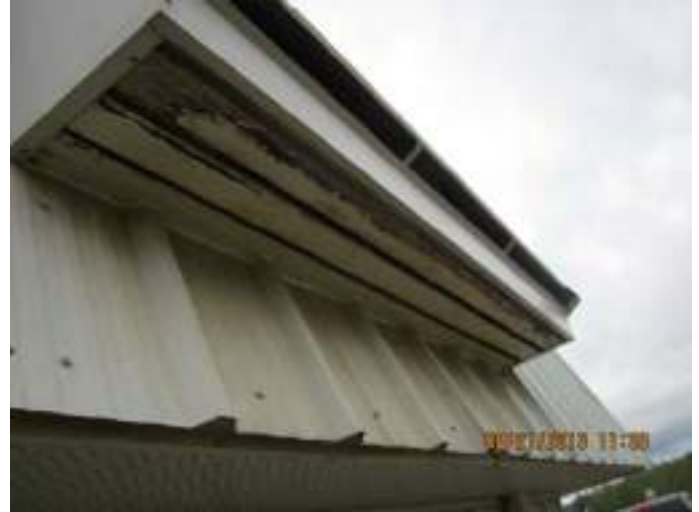
The metal wall siding is in fair condition with some panels having large dents and discolouration. There are some minor gaps in the panel joints at a few locations. The underside of the louver slats are wood and the paint is peeling off. These should be sanded to remove peeling paint and re-painted. The building envelope, including metal siding and roof deck, is generally in fair condition. There are no eaves trough or downspouts.

Photo 6: Paint is peeling off the underside of louver slats and requires sanding and re-painting.

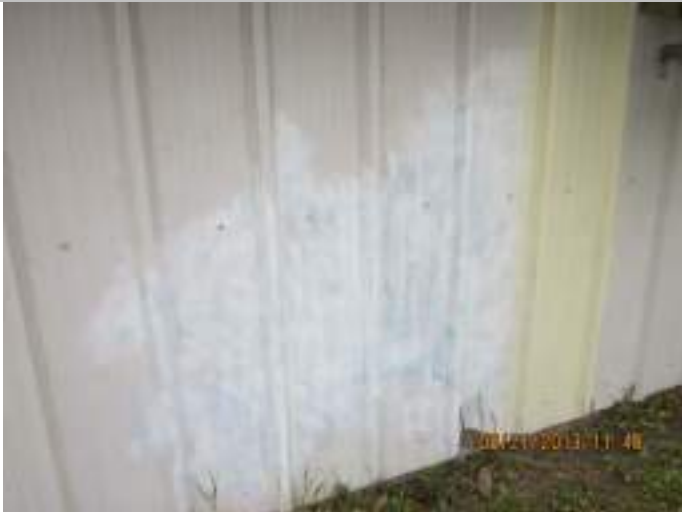
Photo 7: Discoloration of panels at the back of station is primarily an aesthetic issue.

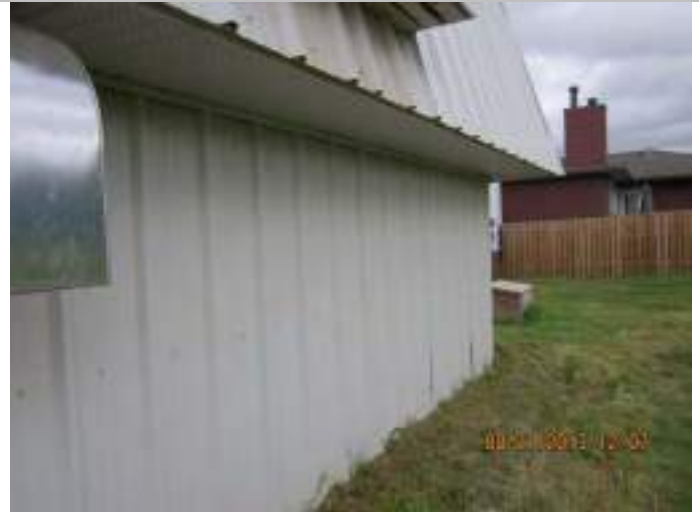
Photo 8: Slight gaps in panel joints.

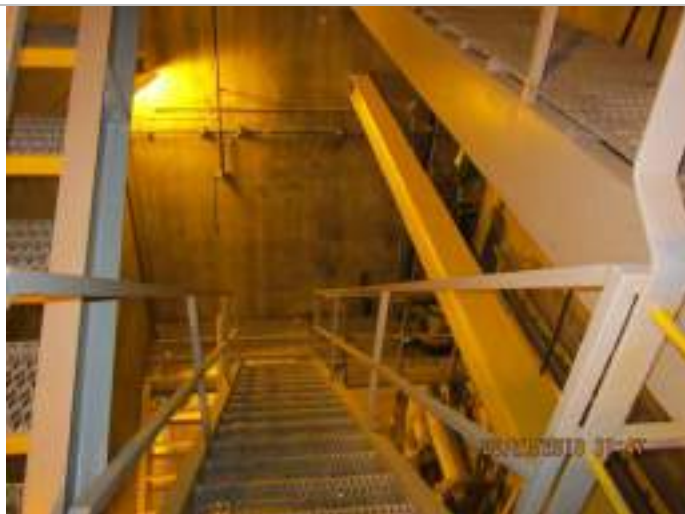
Photo 9: Dry Well stairs and handrail in good condition.

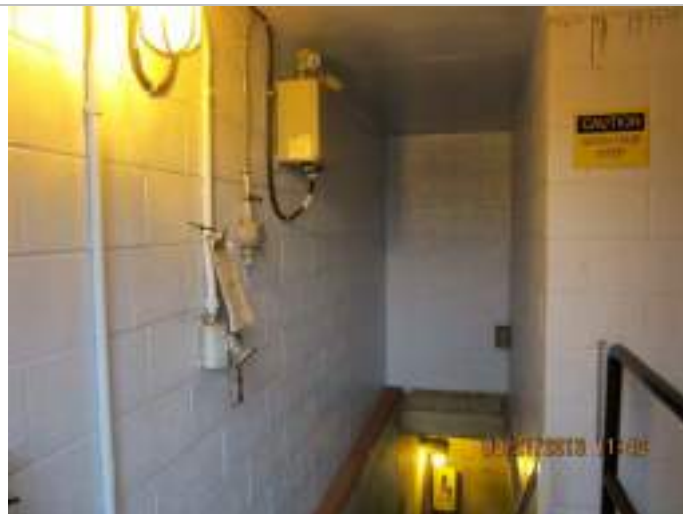
Photo 10: Masonry block wall in Wet Well stairway in good condition.

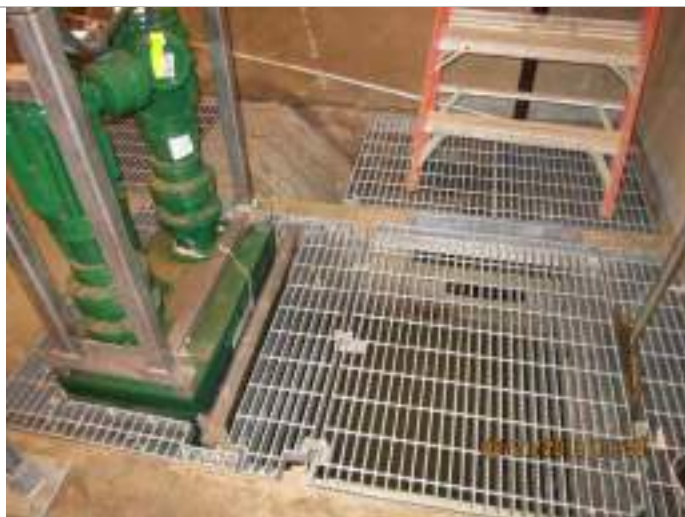
Photo 11: Wet Well grating in good condition.

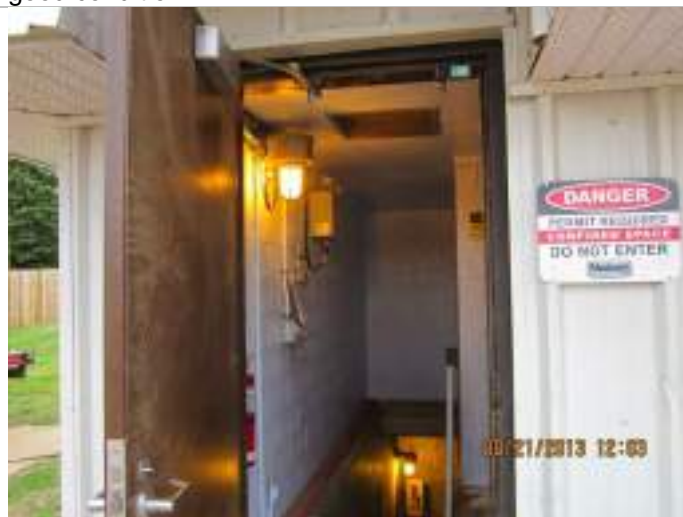
Photo 12: Door to Wet Well in good condition.

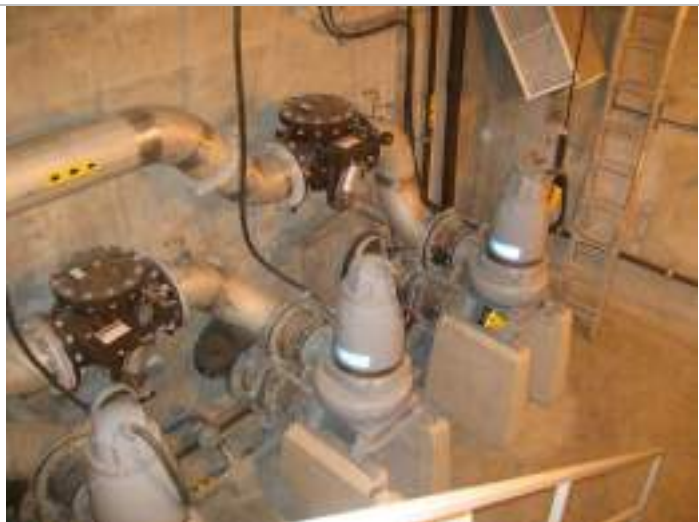
Photo 1: Dry well – Pumps, discharge valves and piping.

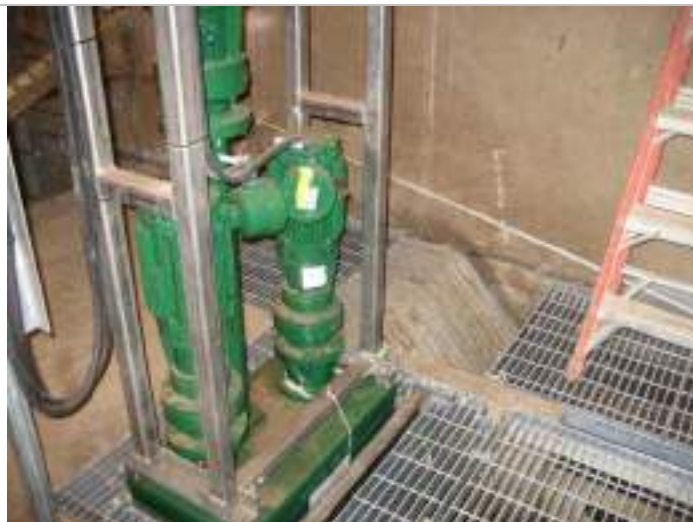
Photo 2: Grinder & bypass channel.

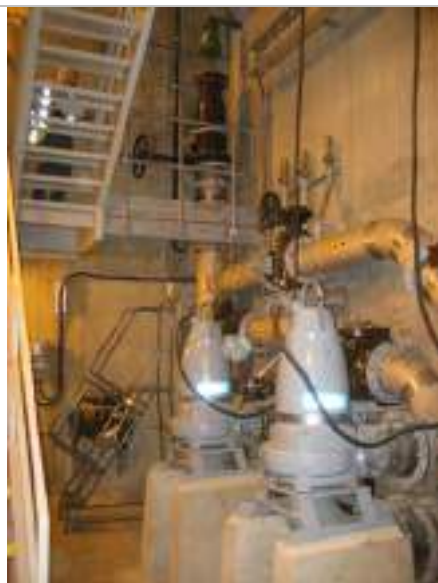
Photo 3: Discharge piping, including flow and pressure monitoring.

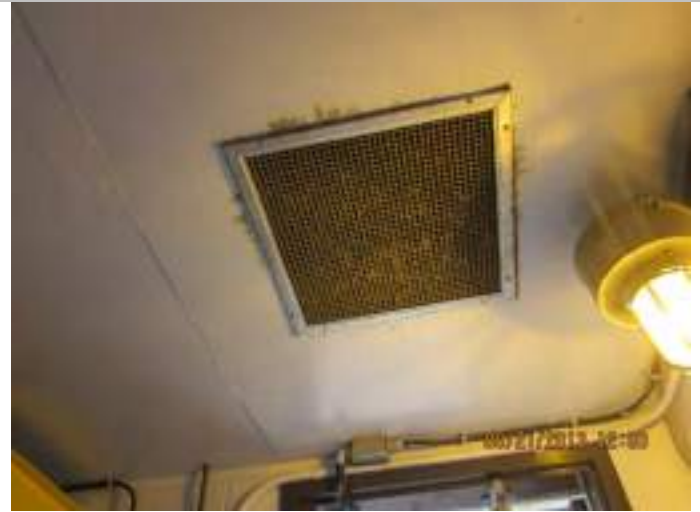
Photo 4: Vent in wet well, top of stair.

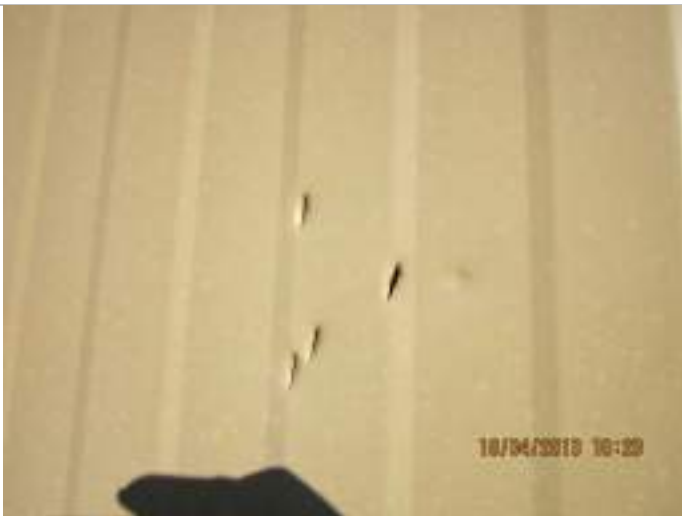
Photo 3: Cuts in cladding.

1. Repair cuts and perforations in the exterior metal wall cladding.
2. Paint over the graffiti on the back exterior wall.
3. Clean up the peeling paint on the Dry Well door and touch up with paint.
4. Remove the corrosion from the handrail on the outside stairs to the Wet Well and repaint.
5. Certified inspection the monorail cranes is required. They were last inspected on 02/09/2013.
6. Remove the corrosion from the Wet Well ladder and repaint.
7. Ensure a fall protection system is in place for personnel using the ladder to access the Wet Well.

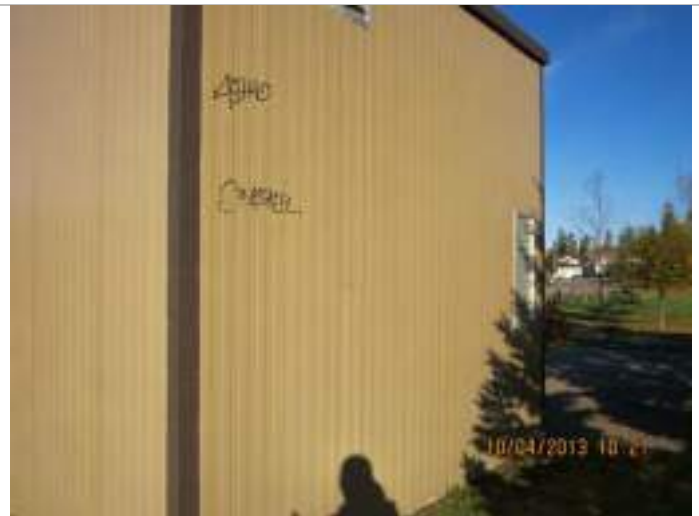
Photo 4: Graffiti on the back exterior wall.

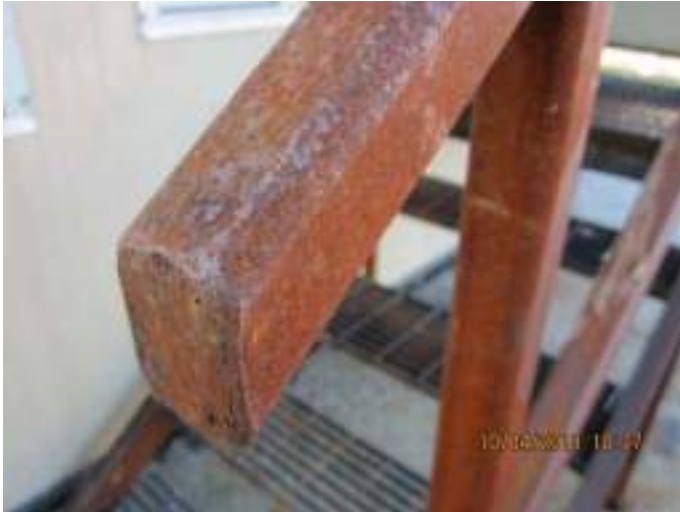
Photo 5: Corrosion on Wet Well outside stair handrail.

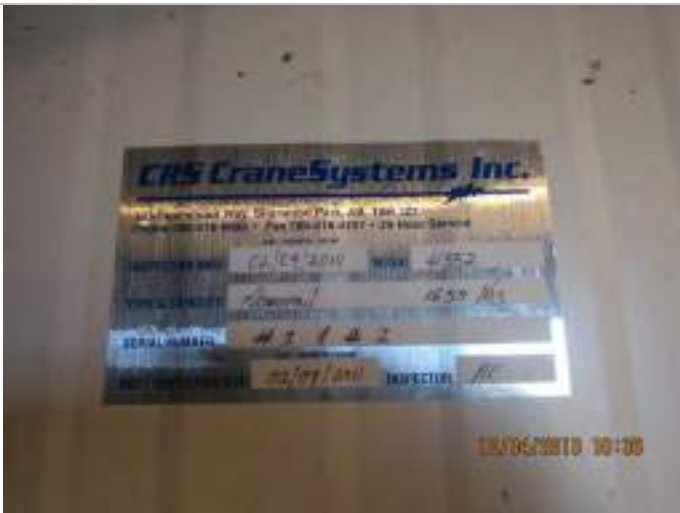
Photo 7: The monorail inspection is expired.

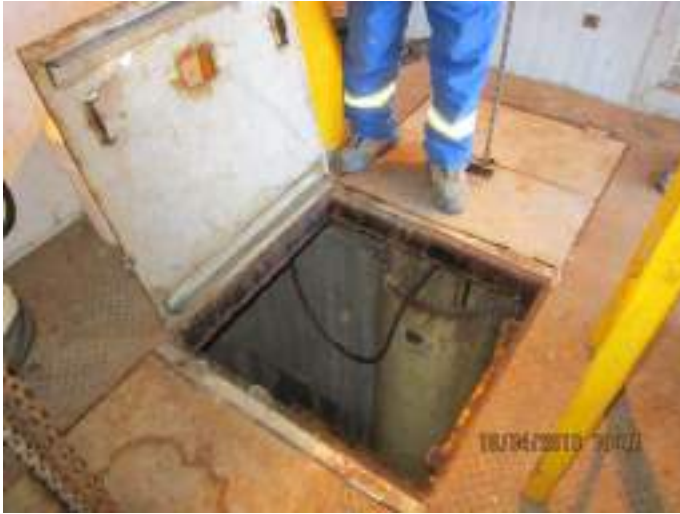
Photo 9: Wet Well access hatch. Utilize fall protection system to access Wet Well.

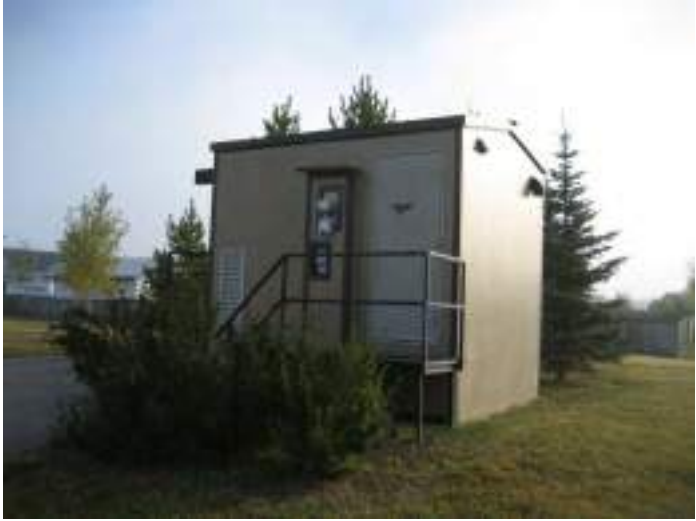
Photo 1: Pump house, showing elevated floor

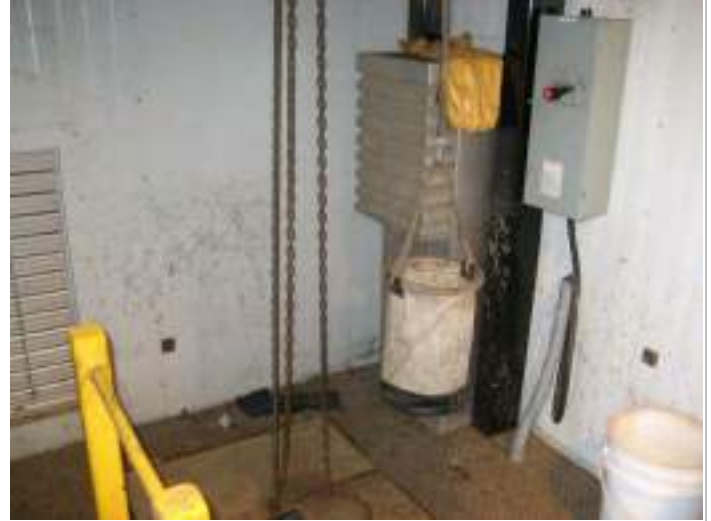
Photo 2: Wet well access hatches, including heater and ductwork.

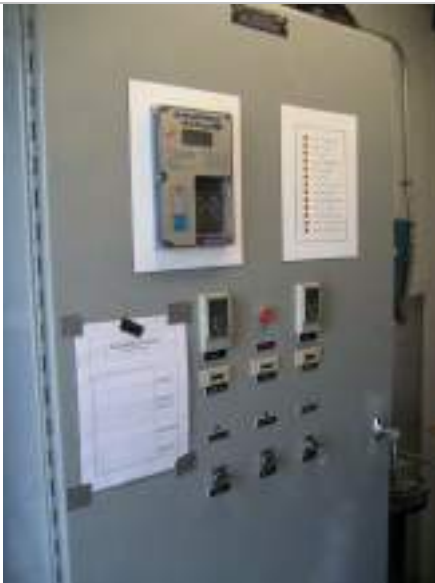
Photo 3: Control panel in electrical room.

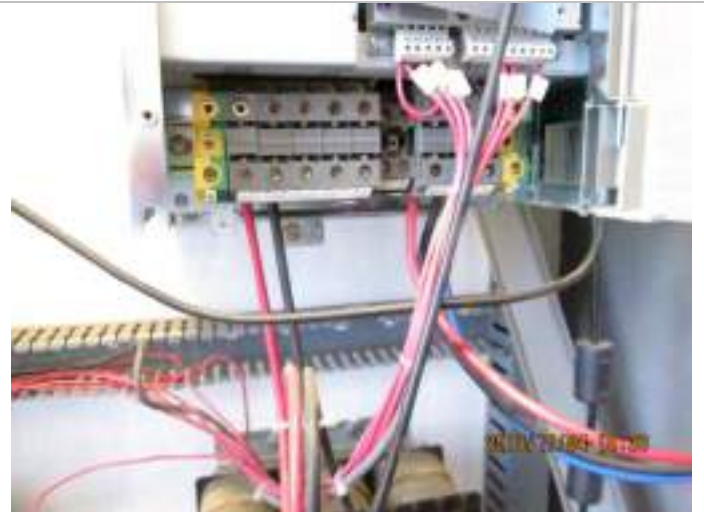
The grounds from the motors should be terminated on the respective VFD. Incorrect installation could result in premature pump failure.

Terminate motor grounds to their respective VFD.

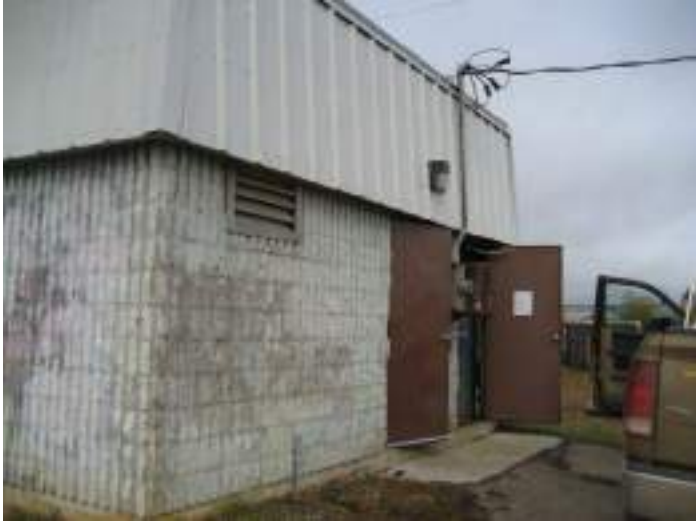
- Elevation – GPS – floor = 364 m. No flood concern.
- Facility was constructed in 1976.
- Facility is in poor condition – substantial rusting on equipment, valves, fittings, piping.

Photo 1: Pumphouse, showing dry well & wet well access

- Upgrade pumps, valves, fitting, piping, etc.
- Install flow, pressure and level monitoring during upgrade.
- Re-test pumps' flow when commissioning upgrade.

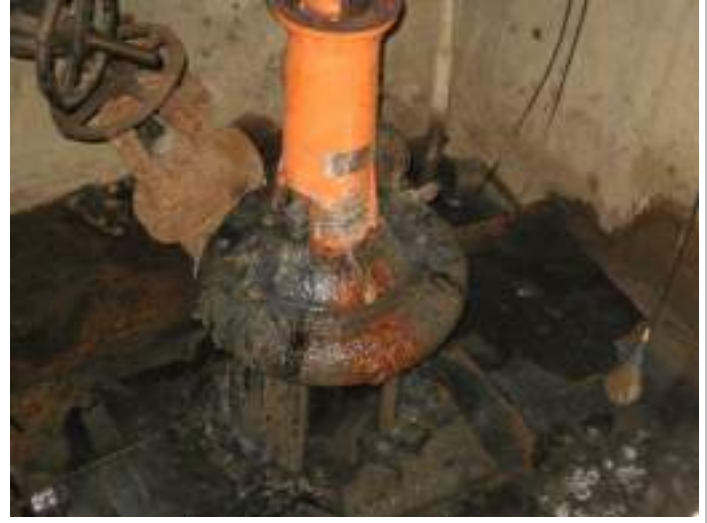
- Pump #1 is leaking severely at its seals.
- Combined flows with 2 pumps running = averages approx. 32 L/sec. This is very inconsistent – may be due to inaccuracies in level measurement, or changes in influent flow.

Photo 2: Pump #1 – Leaking seals.

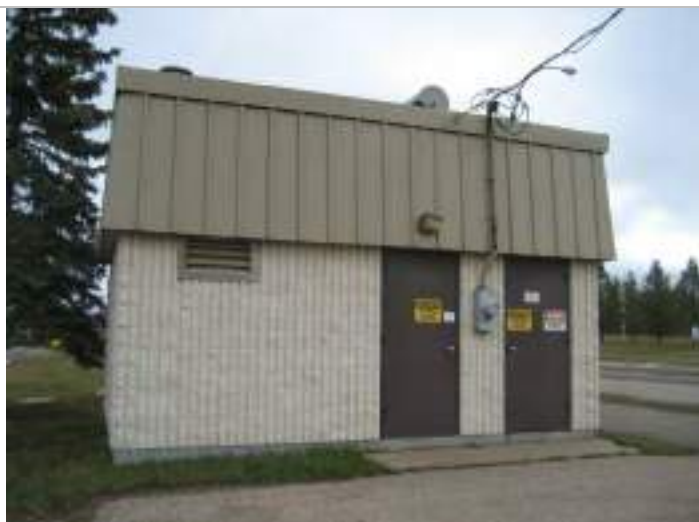
- Elevation – GPS – floor = 376 m. No flood concern.
- Facility was constructed in 1976.
- Facility is in poor condition – substantial rusting on equipment, valves, fittings, piping.

Photo 1: Pumphouse, showing dry well & wet well access

- Upgrade pumps, valves, fittings, piping, etc.
- Install flow, pressure, and level monitoring during upgrade.
- Re-test pumps' flow when commissioning upgrade.

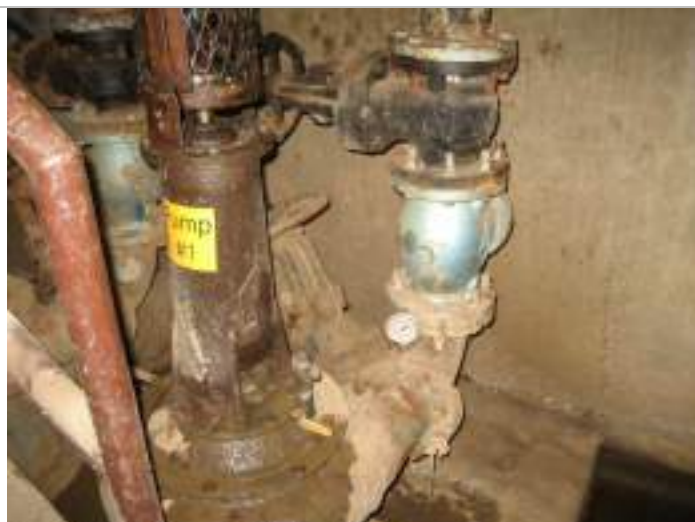
- Pump #1 is leaking slightly at its seals.
- Combined flows with 2 pumps running = averages approx. 50 L/sec. This is very inconsistent – may be due to inaccuracies in level measurement, or changes in influent flow.

Photo 2: Pump #1 – Leaking seals.

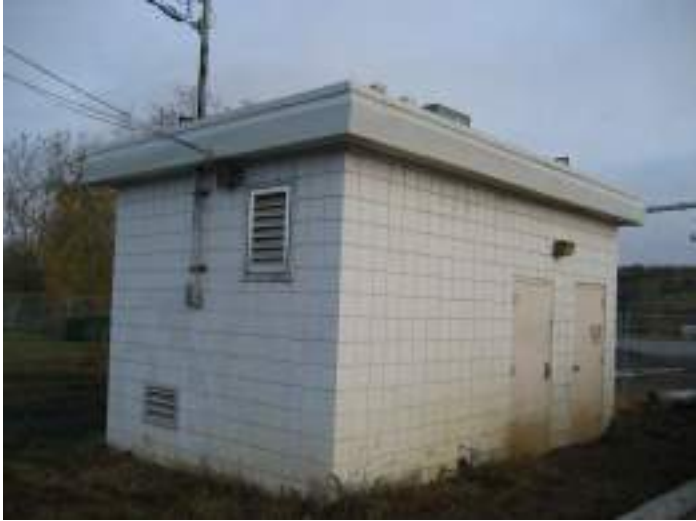
- Elevation – GPS – floor = 252 m. Probable flood concern. Station is located near (west) of Athabasca River.
- Facility was constructed in 1976.
- Facility is in poor condition – substantial rusting on equipment, valves, fittings, piping.

Photo 1: Pumphouse, showing dry well & wet well access

- Upgrade pumps, valves, fittings, piping, etc.
- Install flow, pressure, and level monitoring during upgrade.
- Re-test pumps' flow when commissioning upgrade.

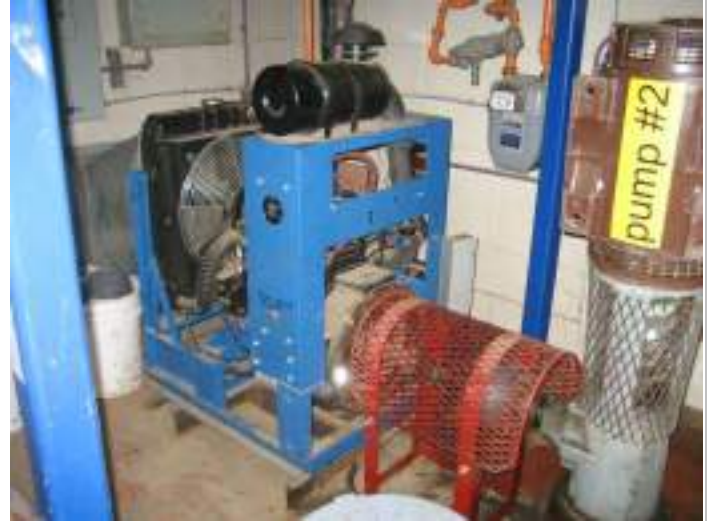
Photo 2: Pump #2 – motor & engine drives.

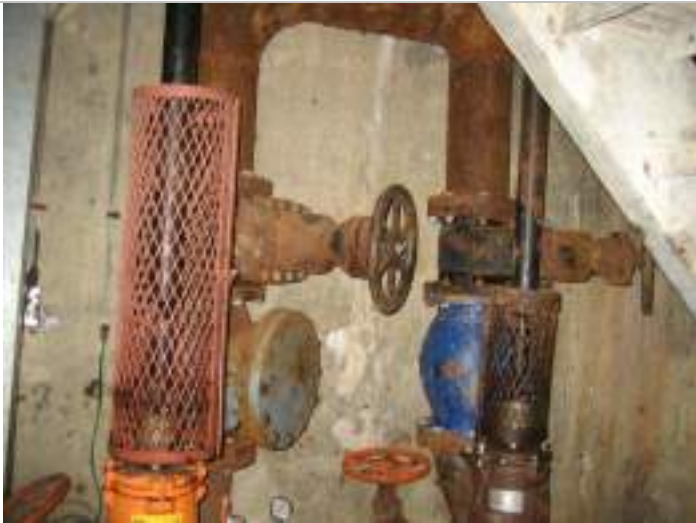
Photo 3: Dry well lower level – rusty fittings & equipment.
